# A cave settlement in Ardahan (Turkey): Harosman

## Abstract

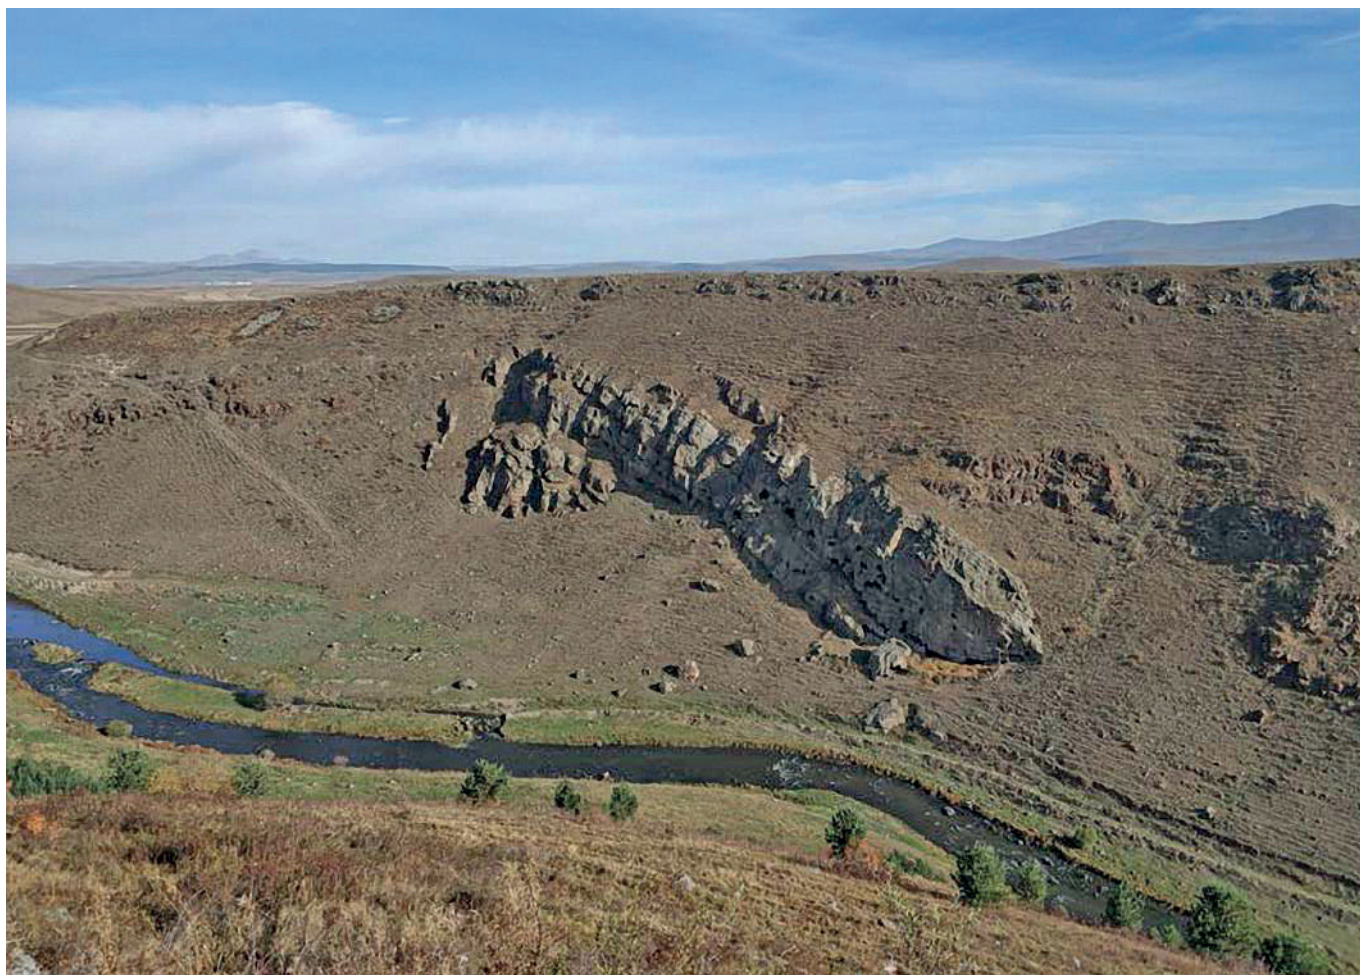
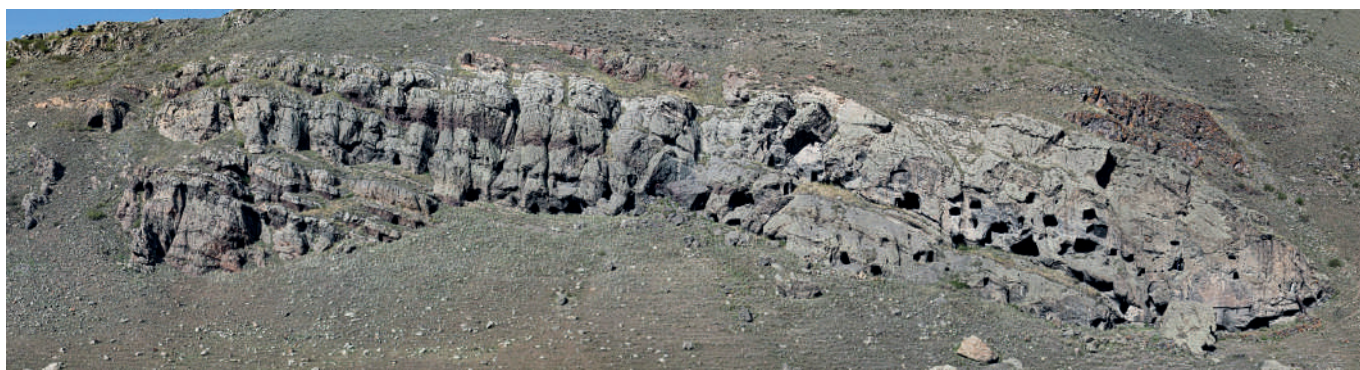
Fig. 2 – Harosman Caves (photo A. O. Turan).

Fig. 3 – Harosman Caves (photo A. O. Turan).

excavate than the soft tuff found in Cappadocia. Harosman Caves is the place that caused us to conduct a survey on “Settlements, Caves and Rock Settlements in the Ardahan-Kür River Basin (2019-2022)”. Harosman Caves, located in the northwest-southeast direction and their facades in the southwest direction, are not natural but were carved into a steeply inclined tuff rock formation by humans. The northwest end of the chain of caves is at an altitude of 1805m, and the southeast end is at an altitude of 1763 m. The rock

on which these caves are located is approximately 236 meters long, 25 meters high and has an average slope of 14% (figs. 2-4).

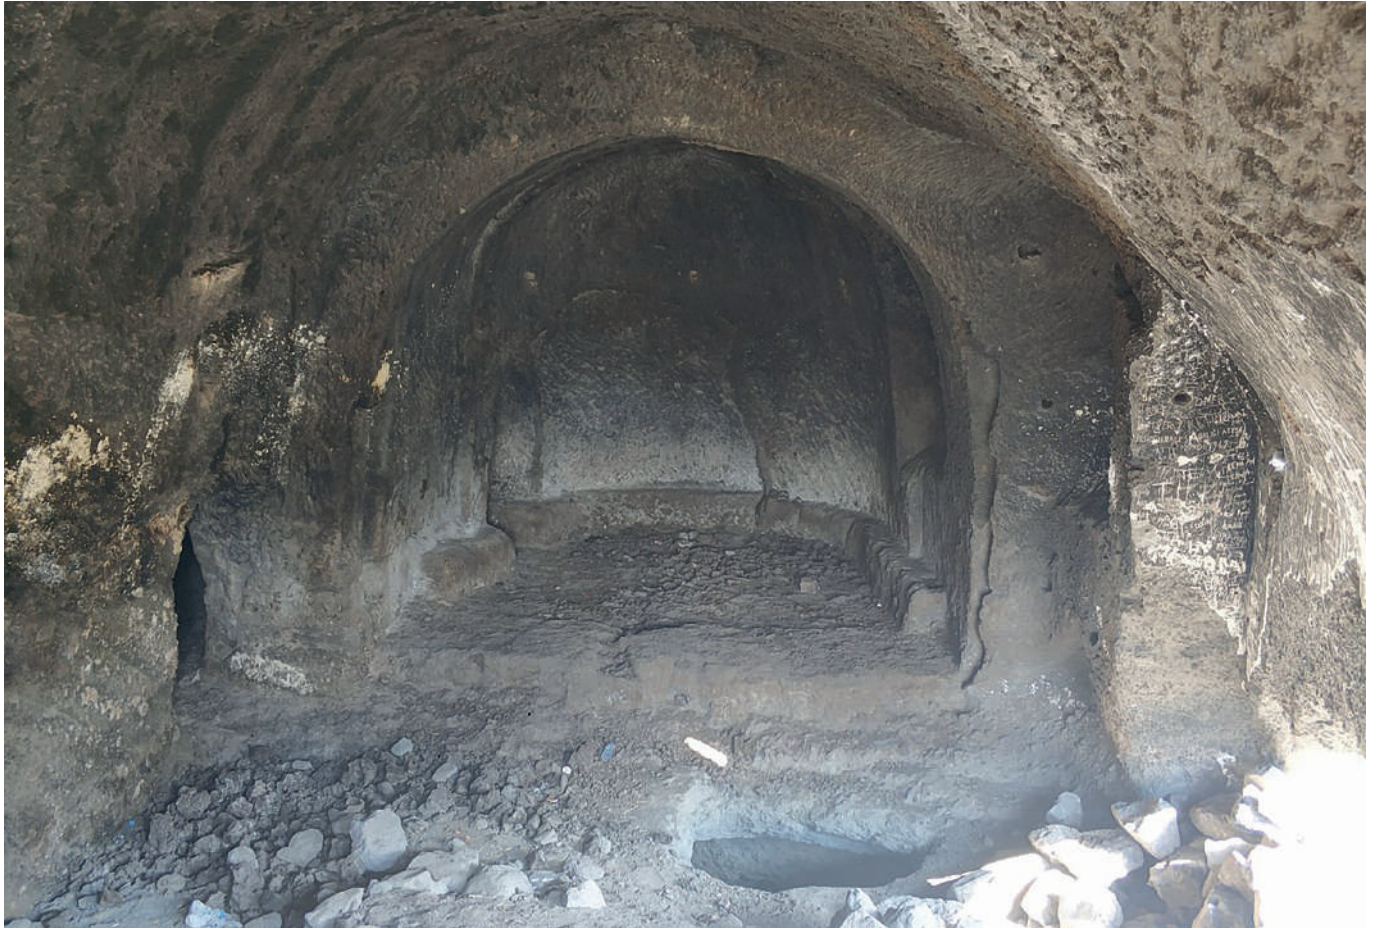
Fig. 5 – Harosman Caves, inside the rock-cut church (photo G. Arda).

been used for shelter or residence. It is observed that almost all of the caves, which were also used as animal shelters until a few years ago, were covered with a dense layer of soot caused by the fire lit for heating and lighting in the period from the first period to the present day. One of the most essential parts of the cave complex is the place arranged as a rock church (fig. 5). It has been used as an animal shelter until recently. The part of this cave, that we think is the only entrance gate, has been partially destroyed for natural reasons. In this section, an unoriginal entrance is seen between a wall and a rock built with coarse stones similar to the limestone type collected from the environment during the recent cave use. Although traces of a thick layer of white plaster were found on the surfaces of some walls of the cave, it was impossible to get an idea whether the other walls were plastered due to the thick oily soot and soot layer on the other walls of the building. The naos is in the west, and the apse is in the east. To the south of the apse, there are sections belonging to *Pastohorion*. It is understood from the grooves opened in channels on the floor, side-upper walls and ceiling that these parts of the rock church were closed and separated from the *naos* part by piers/plates. Except for the apse part, culverts were opened along the northern wall of the cave. There is also a *martyrion* part in this rock church. Unfortunately, it

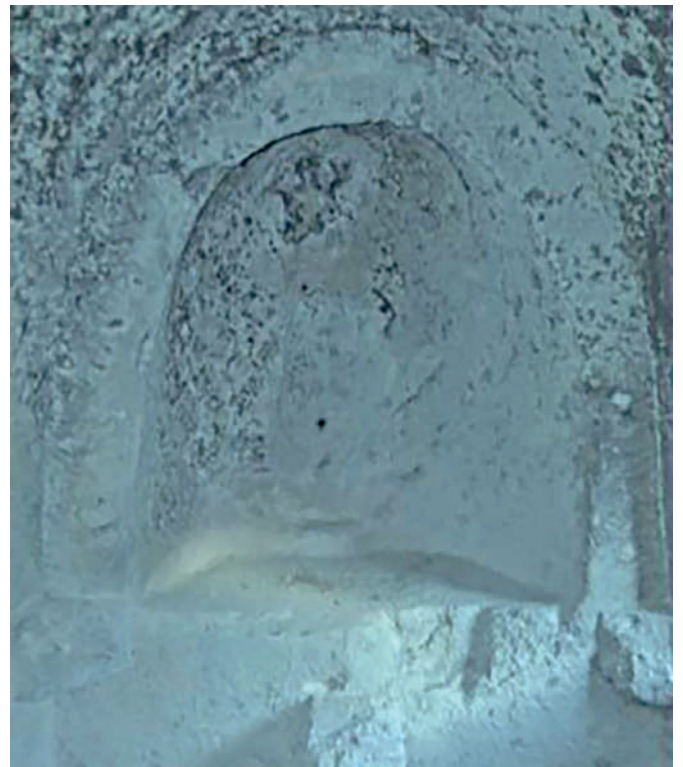
Some of the table-like rock arrangements that may have been used as altars/altars in some caves are intact; on the other hand, a large part was destroyed, or only the lower parts resting on the ground remained intact. In addition, arrangements made as places for offerings in the caves were also identified (fig. 6).

Fig. 6 – Harosman Caves, votive place (photo G. Arda).

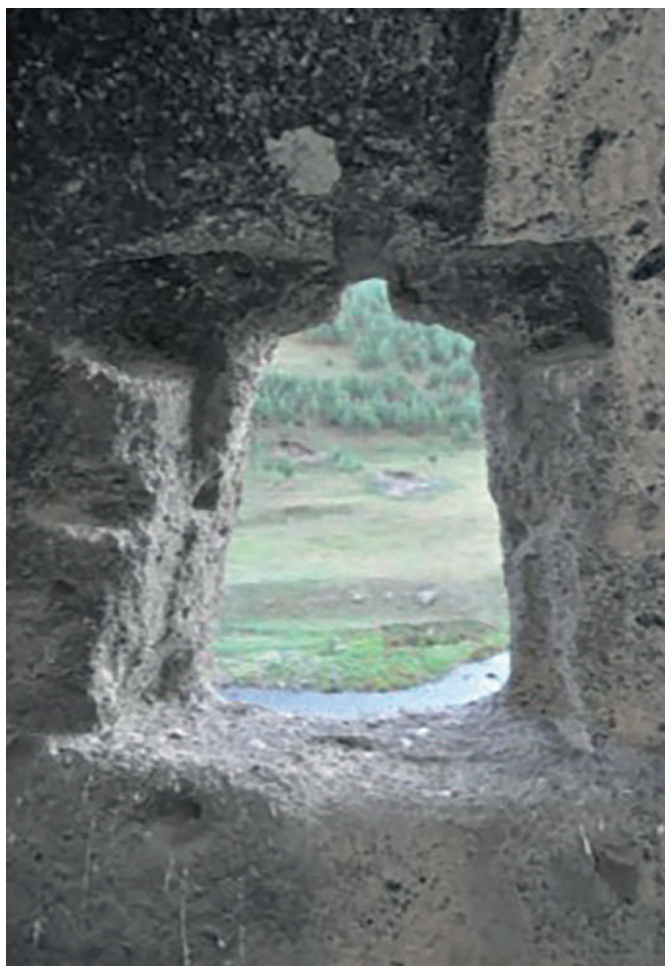
Fig. 7 – Harosman Caves, entrance (photo G. Arda).

side. Channel-shaped cavities and stepped formations on the sills of some cave entrances are traces of mechanisms used in door closing (fig. 7). There are culverts or lighting holes in the northern part of the caves and on the facades facing the river, and almost all of them have shafts. Seating benches, small and large niches on the walls and hollows used as shelves can be seen in almost all the spaces built into the rock. In addition to the single-storey ones, caves and places with two and three floors were also identified. Also noteworthy is a cave that has begun to be worked on but has not been completed. The side walls of the room after the cave entrance were partially worked out; unfinished chipped work can be seen on one wall and traces of an incomplete shaft creation can be seen on another wall. In our study in the area where the Harosman Caves are located, the remains of structures related to these were found in the southeast of this rock mass, in front of the caves, just at the foot of them and just southwest. Rows of worked stones were identified in the southeast, but the integrity of a building could not be fully understood due to seasonal conditions and the high grass cover of the land. At the foot of the caves, the wall made of processed stones that we found on the side of the road leading to the caves has survived to the present day, partially preserved. We also determined that a road formed by shaping a natural rock in the form of a ladder was used to reach the caves in the front level to the ones on the upper level. A few pottery fragments among the heaps of soil belonging to illegal excavators show Chalcolithic and medieval characteristics and provide evidence for using caves in pre-Christian times.
