Rock-cut Byzantine churches of Koramaz Valley (Kayseri, Turkey)

Ali Yamaç¹

Abstract

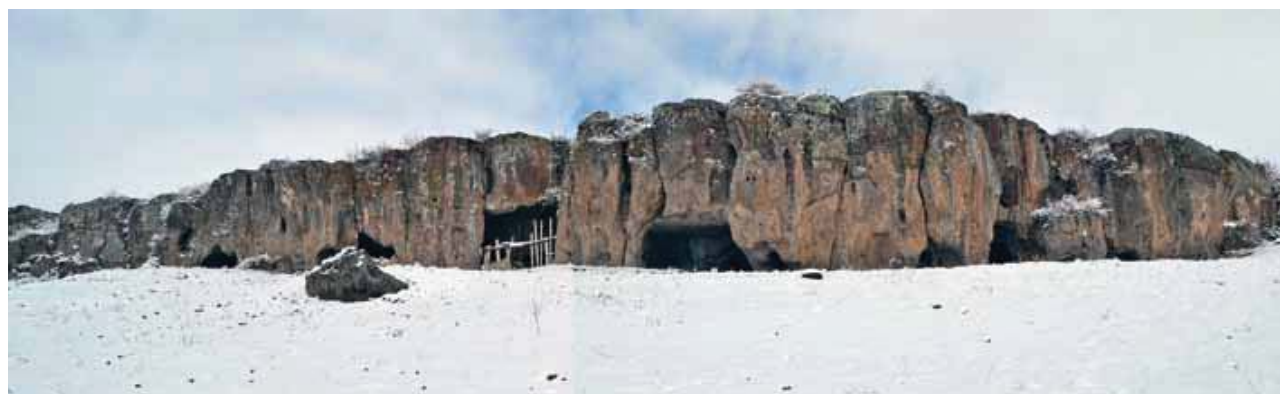
Fig. 2 – General view of Subaşı rock-cut complex (photo A. Yamaç).

The previous name of Subaşı Village was Üskübü and earlier it was Skopi. There is a huge complicated structure, located 200 m northwest of Subaşı Village, dug on a rocky slope, with a church as well. In this settlement, excavated on a steep wall and located on a line with a length of 180 m, there are 11 different structures of all sizes. Some are connected with tunnels and this complex, consisting of some small chambers and a room in the size of 100 sq m, as well as a kitchen with oven and chimney, is most possibly a monastery with its church, courtyard, kitchen, dining hall, living spaces, and ceremonial chamber (fig. 2, fig. 3, fig. 4).

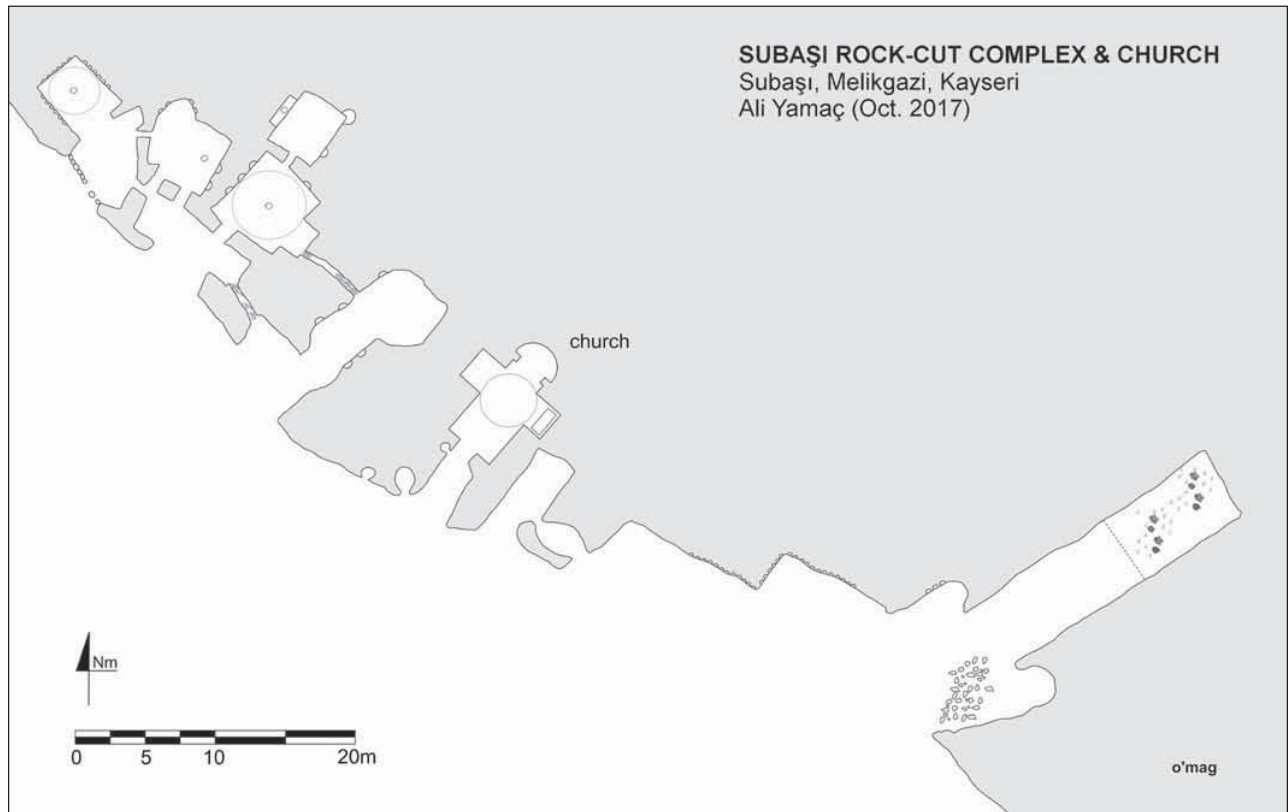
Fig. 3 – General plan of Subaşı rock-cut complex (drawn A. Yamaç).

The church is a cross planned structure with an approximately rectangular narthex in front, barrel

vaulted, with grave niches at the entrance and the south wall partially destroyed. The church is one of the two biggest rock-cut churches in Koramaz Valley together with Vekse Church No 1; taking into consideration the similar examples in Göreme (Karakaya, 2014), it can be dated to the 10th - 11th centuries.

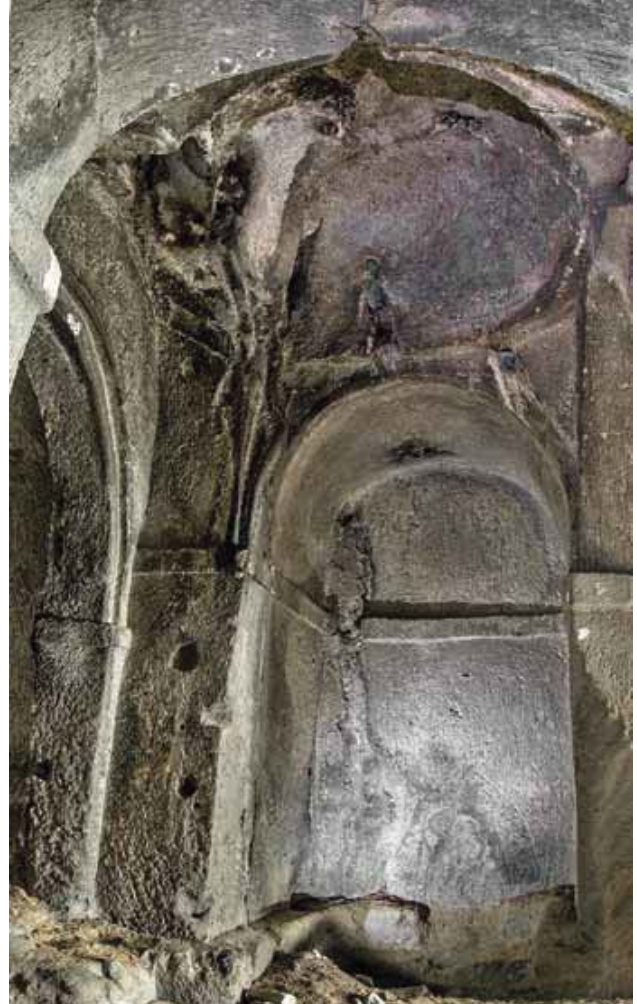
Fig. 4 – Church of rock-cut complex of Subaşı (photo A.E. Keskin).

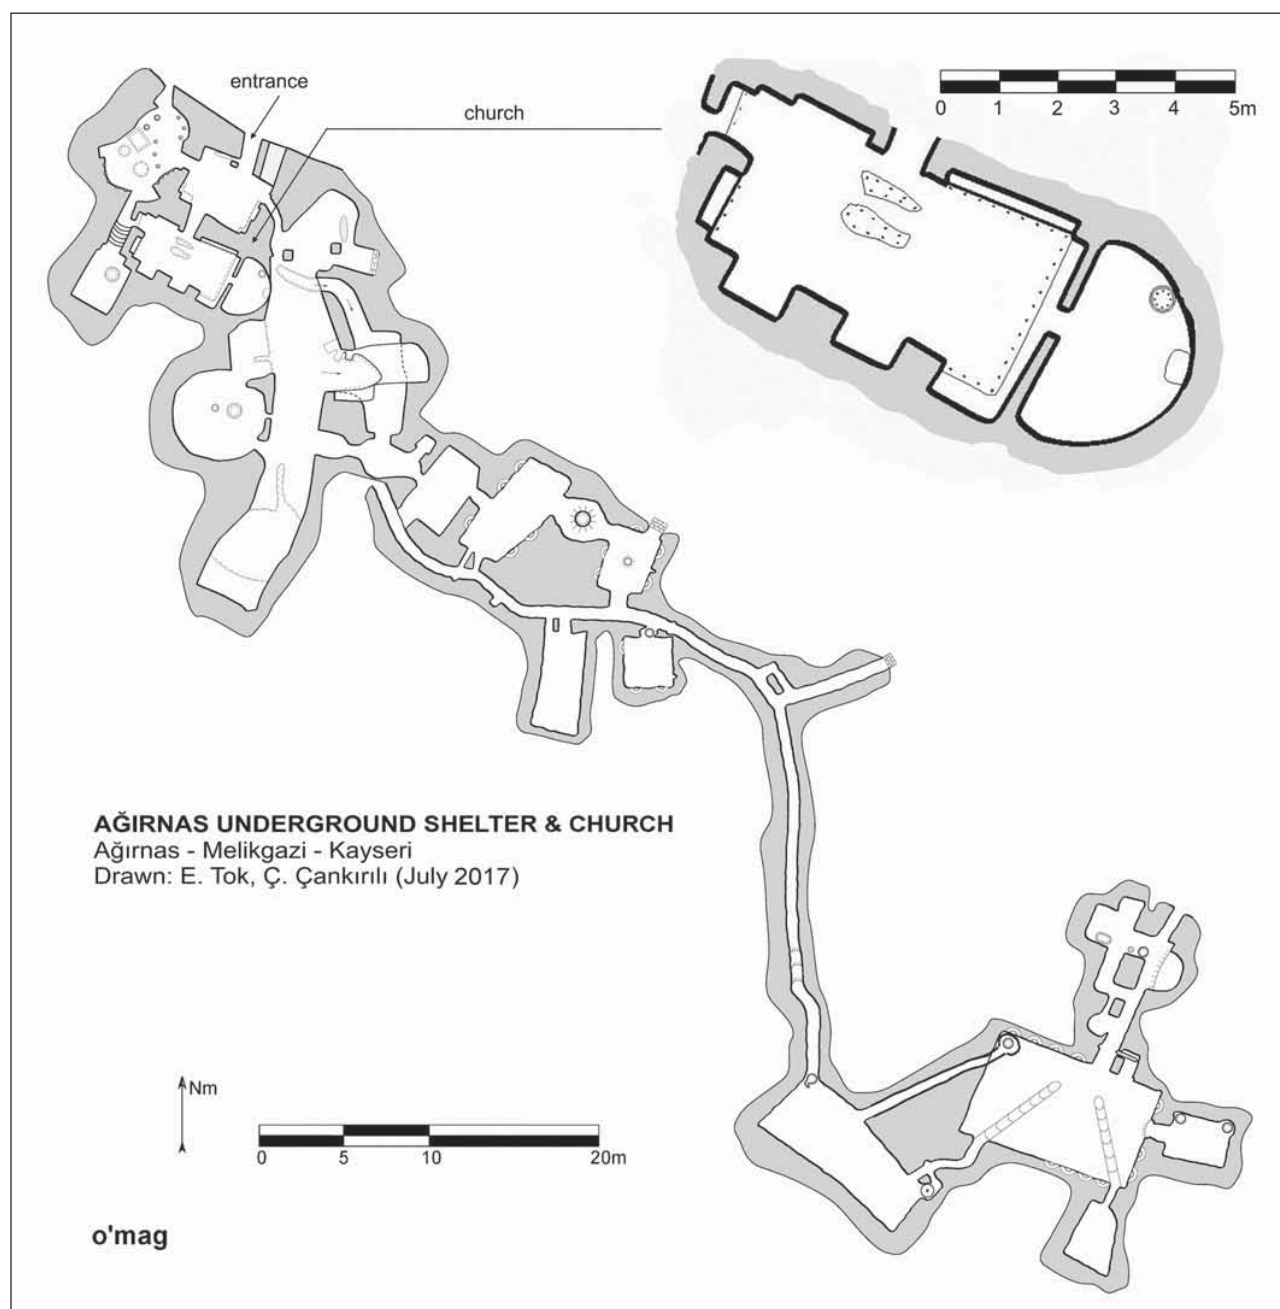
Fig. 5 – Plan of Ağırnas Underground Shelter. On the upper right corner the larger-scale church is reproduced (drawn E. Tok & Ç. Çankırılı).

during 19th century, there are a total of 15 rock-cut churches in and around Ağırnas Village, and only one of them is in the village. This church is inside the “Ağırnas Underground Shelter” which is located 200 m south of the village center, dug on a rocky slope on the east of Koramaz Valley, left bank. The main entrance of this structure, which is currently open to tourists, is protected with a millstone door. After the first room in the entrance, there is a church with a length of 8.40 m and the main axis of northwest-southeast direction. As often encountered in Cappadocia, the church has

a barrel-vault ceiling and a horseshoe apse. There are three niches on the south wall of the church and a single niche both on west and north walls. A passage on the west wall connects the church to storage chambers. Most possibly the church must have been excavated within the underground shelter, between 9th-11th centuries (fig. 5, fig. 6).

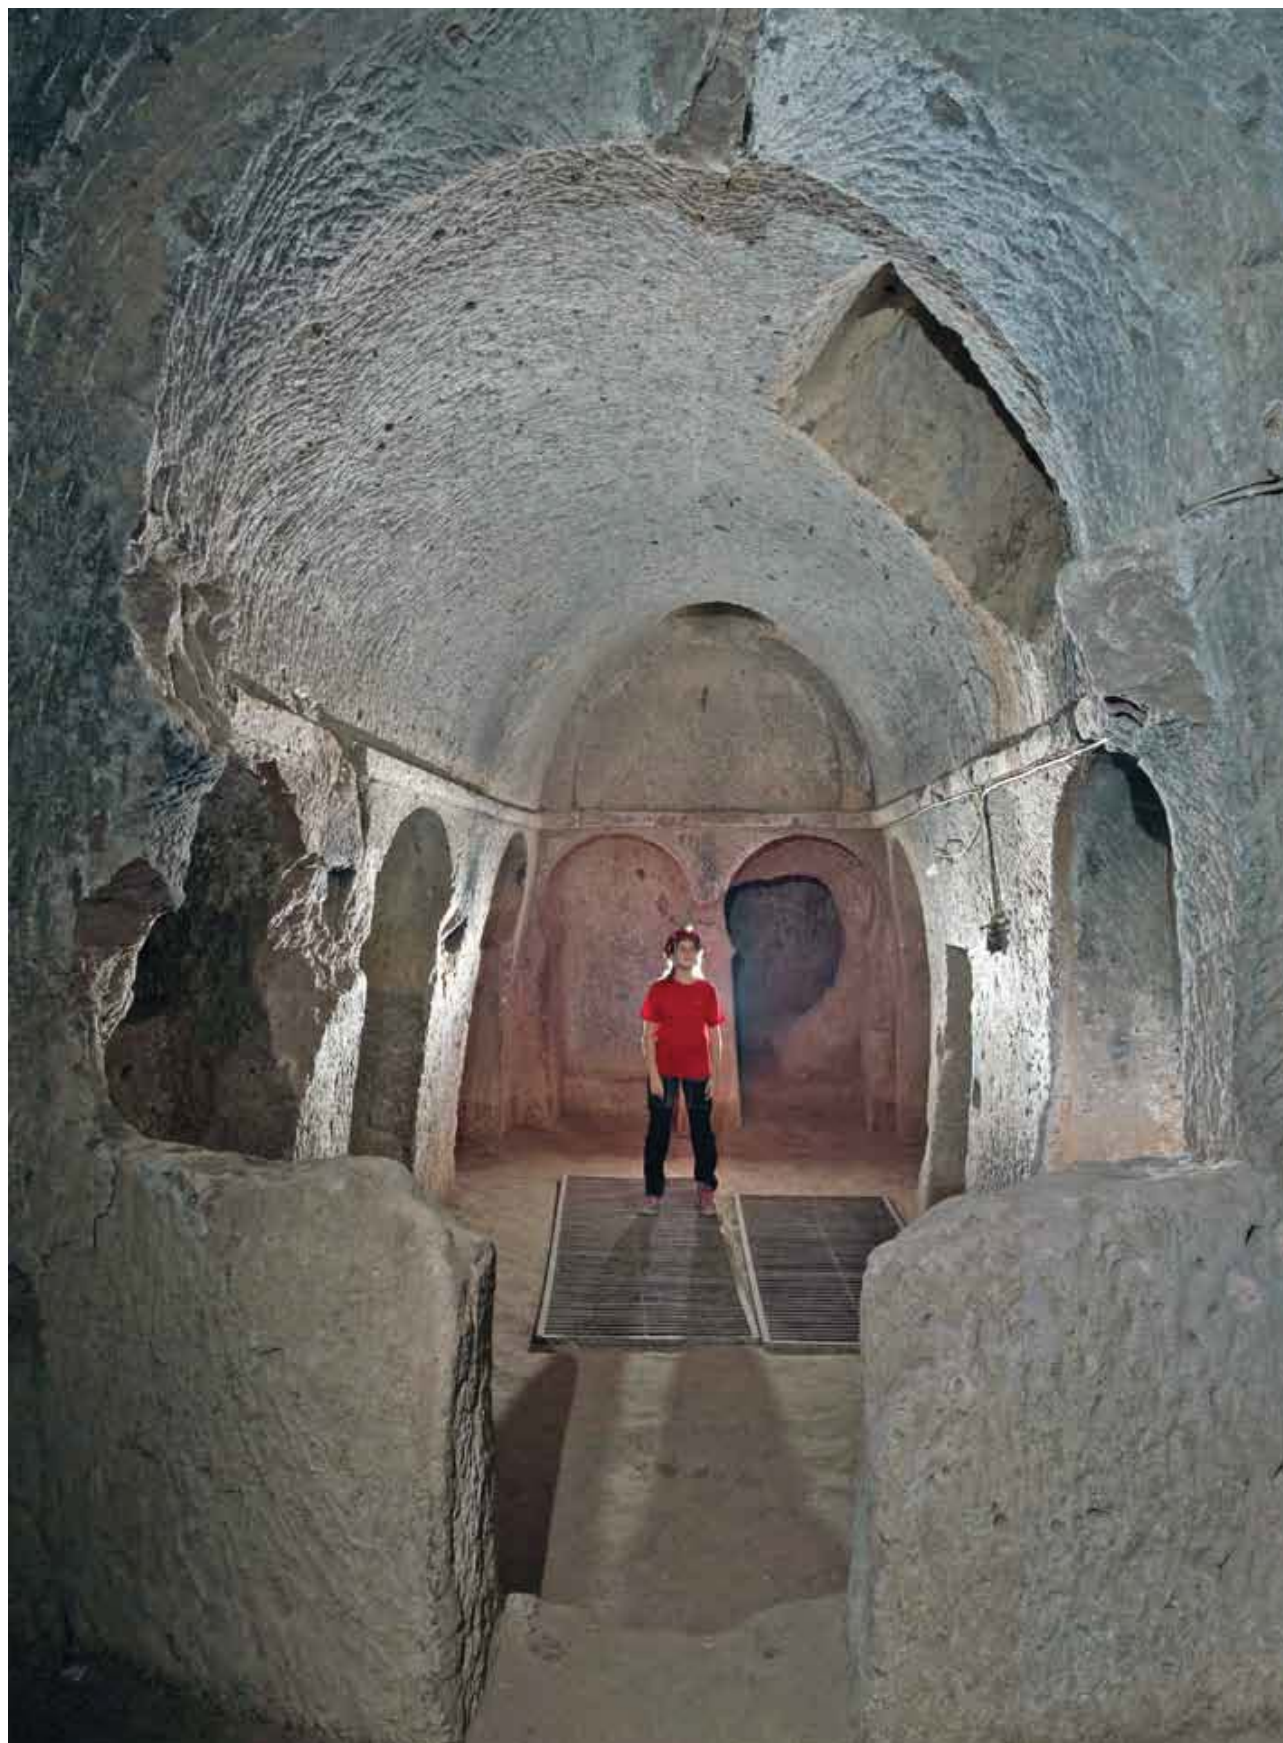
Fig. 6 – Church of Ağırnas Underground Shelter (photo R. Straub).

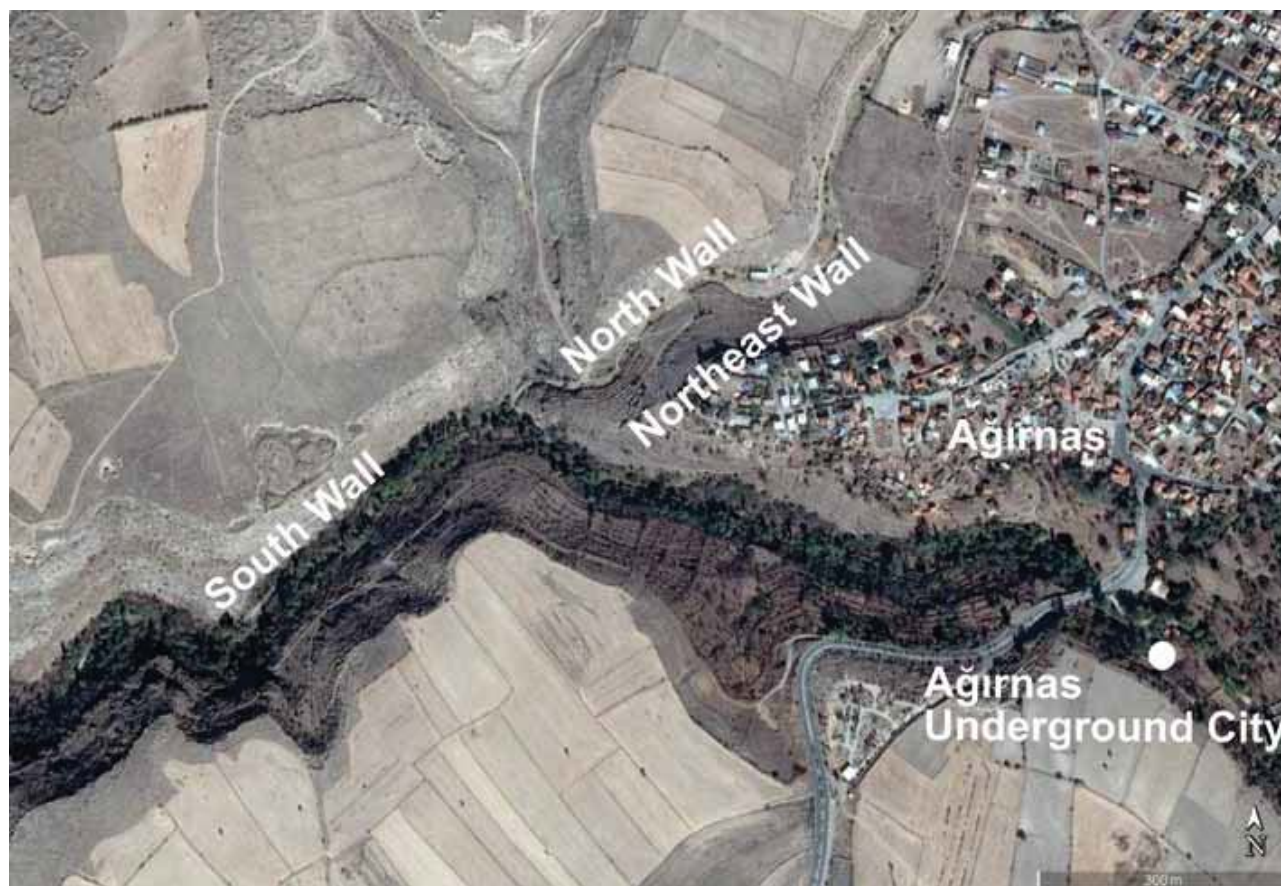
Fig. 7 – Korumaz Valley develops south of Ağırnas Village, with another small branch towards North. All those three rock walls of the valley are full of rock-cut dwellings (after Google Earth-elaboration A. Yamaç).

structures have been explored and surveyed. Though most of these structures are houses, storage units, barns, or dovecotes, there are also 14 churches. By taking into consideration the churches and underground shelters in these settlements, rock-cut architecture in this region can also be dated between the 7th and 11th centuries (Lamesa, 2011). Rock-cut churches in these cliff settlements will be explained according to their locations on the walls (fig.7).

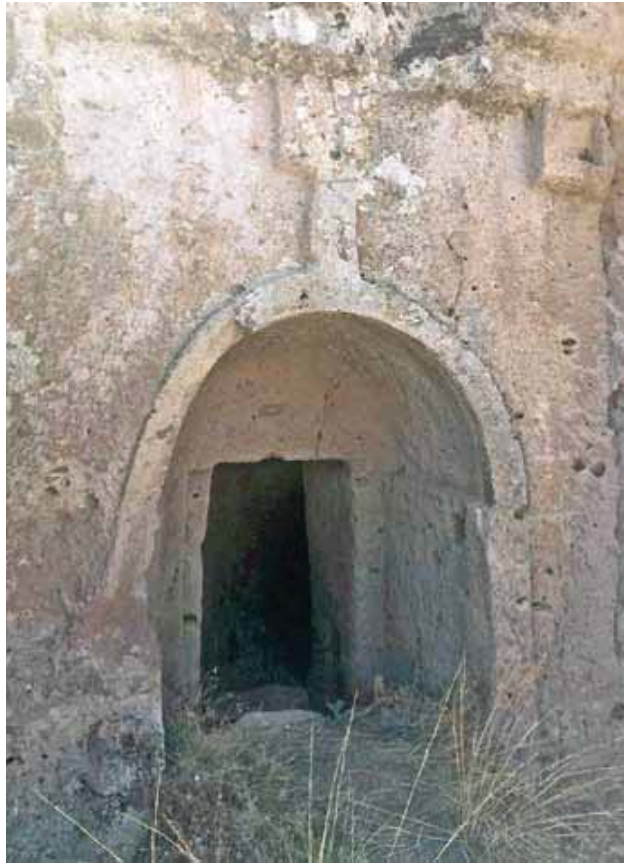
Fig. 8 – Entrance of Höngele Church. Ornament style and interior of the structure suggests that previously it was a Roman tomb (photo B. Yazlık).

Both the entrance and the apse of this church are facing east and the main axis of the structure is towards the north. The window behind the apse is the only example in the region. There are two arcosolium graves next to each other on the northern wall of the church, which measures 6.03 m × 2.93 m and has a height of 3 m. The door of the church has highly detailed workmanship and the embossed cross above the entrance door is rare. There is a grave on the right and left of the entrance door in the atrium. These graves are thought to belong to the donors of the church. The unique workmanship at the entrance gate and the arcosolium tombs in it suggest that this structure could be excavated as a Roman tomb before it was converted into a church around the 11th century (fig.8).

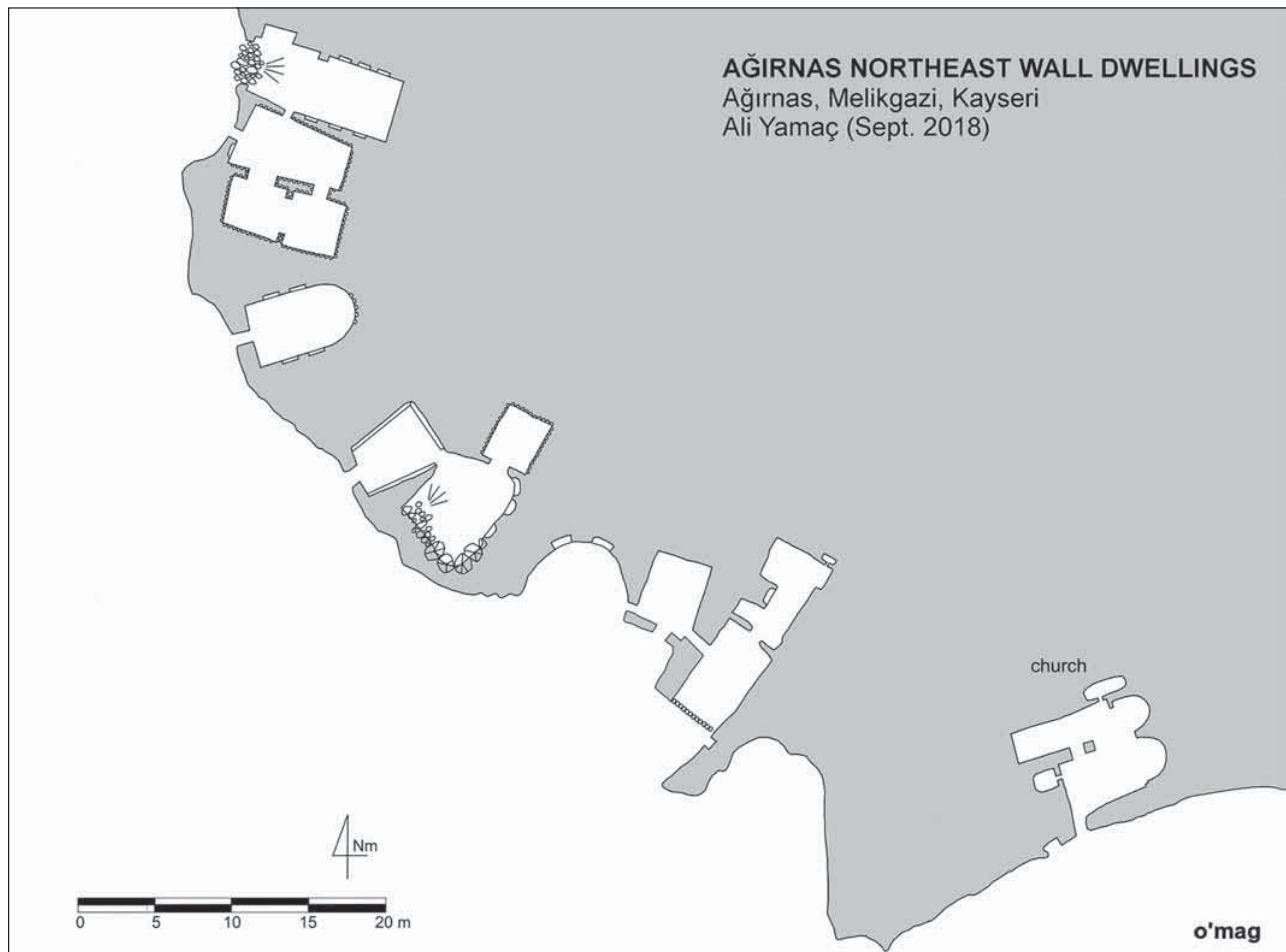
Fig. 9 – General plan of Northeast Wall Dwellings of Ağırnas Village. Gilaburulu Church can be seen at the bottom right corner of the plan (drawn A. Yamaç).

settlements on the northeastern bank of the stream. At the point where the valley made a fork and under the newly built houses of the village, there are seven rock-cut settlements and two are churches. At the most southeastern end of the complex, there is a double apse Gilaburulu Church (fig.9) with some frescoes, even though it has been heavily damaged. This church has a total area of 66 sq m and is supported by a single column carved into the rock body. North nave of the church is significantly larger than the south nave and there are silo-like underground structures dug into the ground in front of both apses.

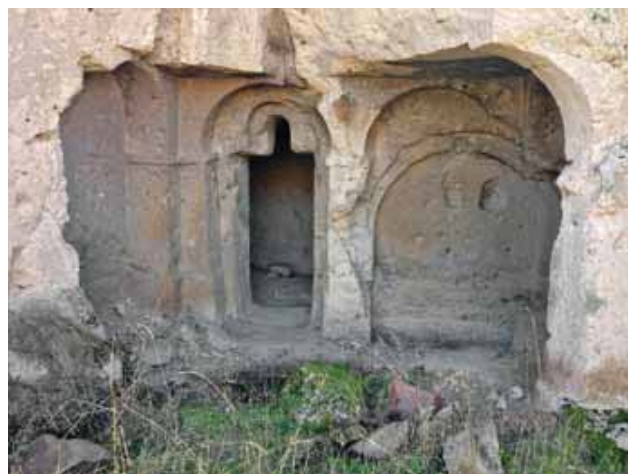
Fig. 10 – Entrance of Görmis Church (photo A. Yamaç).

The peculiarity of this structure is that it is the only structure on the east slope of Koramaz Valley around Ağırnas and all other rock-cut structures on the main-line of the valley are located on the opposite, western wall. The entrance door of this church faces north and a total of 6 graves, probably belonging to the donors of the church, are located in the atrium of the church. The templon and the altar of the church have survived to the present day. It appears that the access to the church was partially destroyed. A room on the right side of the entrance and a rock tomb on the floor are interesting. This church, which is an 11th century Byzantine structure, measures 6.88 m × 2.60 m and a height of 3.54 m, has been well preserved compared to its counterparts. The rectangular church has semi-circular apse, an altar carved from the rock body, and three semicircular niches on the north wall of the nave (fig. 10, fig.11).

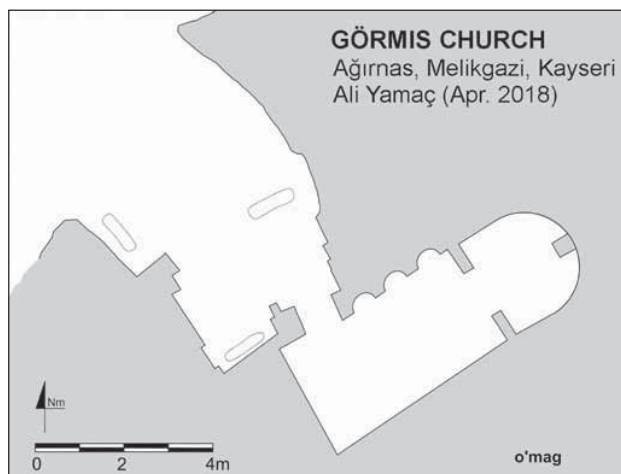
Fig. 11 – Plan of Görmis Church (drawn A. Yamaç).

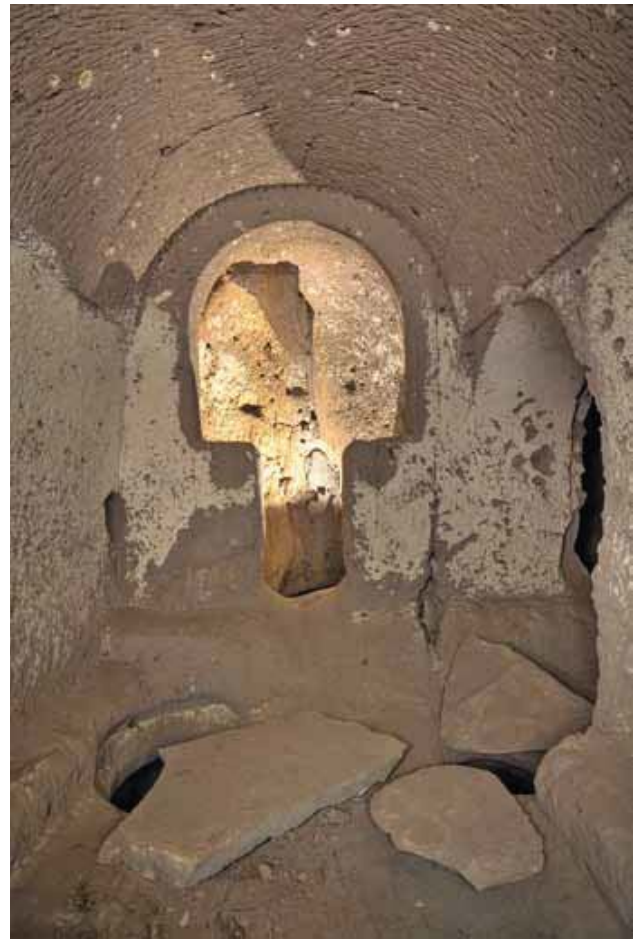
Fig. 13 – A small Byzantine church in Dimitre Village (photo D. Albov).

tal 229 rock-cut settlements have been explored and surveyed. Among these structures, most of which are dwelling, barn, and dovecote, there are also seven churches. Those small rock-cut churches are architecturally quite similar; all of them are with a length of 6-7 m and have a horseshoe apse (fig. 13).

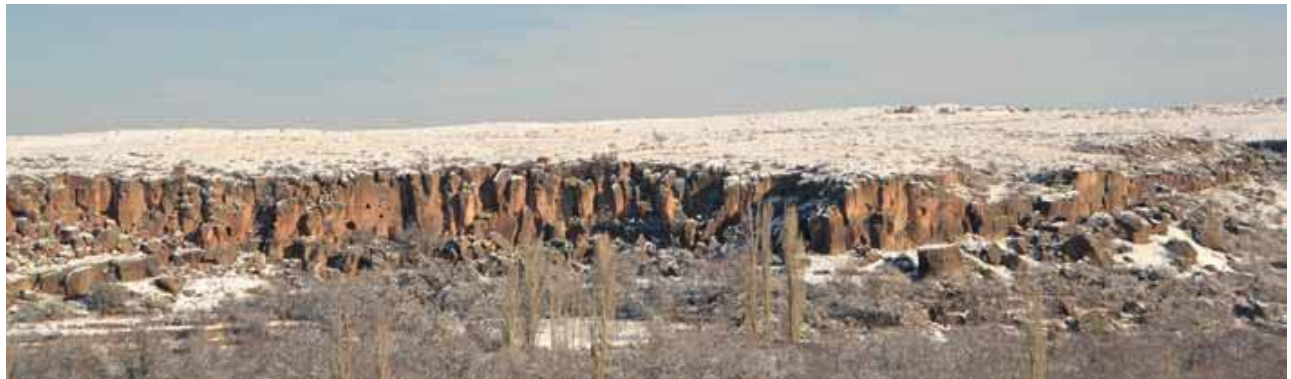
Fig. 14 – Wall of Koramaz Valley to the north of Vekse Village. In this sector there are few rock-cut dwellings and four churches (photo A. Yamaç).

The next village after Dimitre in Koramaz Valley is Vekse which is located 2.5 km west and is the smallest village of this valley. The opposite slopes of the valley consist of red-colored volcanic rocks reaching to a height of 20 m from place to place and extending like a wall from one end to the other (fig. 14). Structurally, Vekse is very similar to Ağırnas. On one side of the valley, there is the current village and on the other side, there are the rock-cut structures. Differently from Ağırnas and Dimitre, there are not many rock-cut settlements on the walls of Koramaz Valley extending in front of Vekse. The number of rock-cut structures on the walls is just 12 in total and five of these structures are churches. Apart from Vekse Church No. 1, all other four churches have approximately a 6 m long axis and horseshoe apse plan.

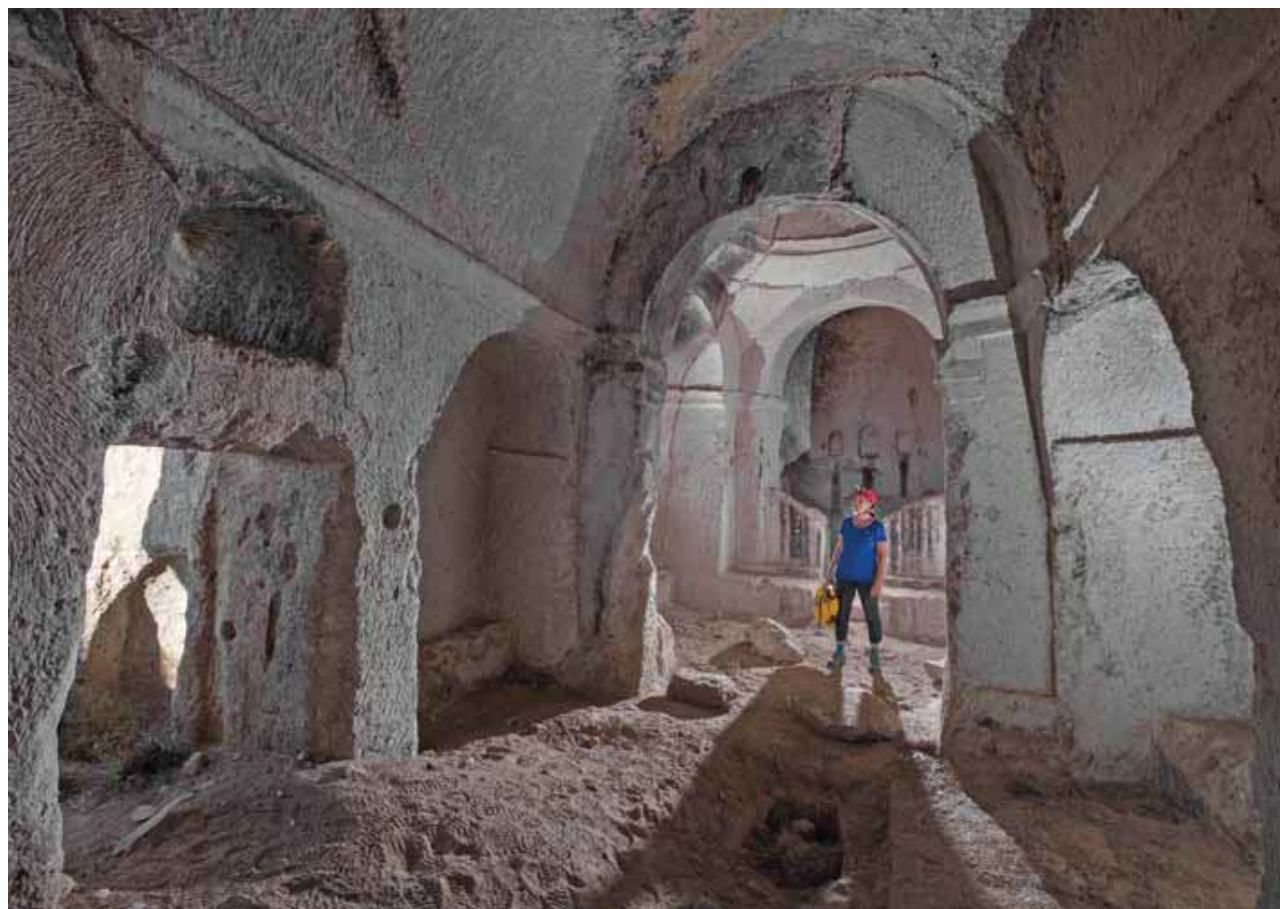
Fig. 15 – Vekse Church No. 1, view from the nave towards the apse (photo R. Straub).

The rock-cut church of Vekse No. 1 is situated 400 meters south-east from the main settlement of Vekse and on the top of a cliff. The entrance of the church is located on the north wall. It was partly destroyed but on the broken wall we still can see the square exonarthex overlapped by the semicircular vault. The semicircular niches are carved in the lower parts of the west and east walls. The naos is a Byzantium type “compact cross-in-square” style. In the apse there is still the rectangular-shaped altar carved in a rock protrusion. There are three arch-niches over the altar. On the north wall a small rock-cut table (the prothesis) is present. Connection with dome is made by the flat pendentives of triangular shape. To the south of the naos the parekklesion of rectangular shape that extend on the axis north-south is adjoining. It is covered by a barrel vault. Along the west wall of the parekklesion a rock-cut bench has been obtained and in the south corner a burial pit of rectangular shape is situated. On the east side the second apse was excavated with a rock-cut altar in the centre and two rock-cut shelves. To the west of the naos adjoining large narthex extends on the east-west axis. It is overlaid by a high barrel vault. In the east part of the narthex,

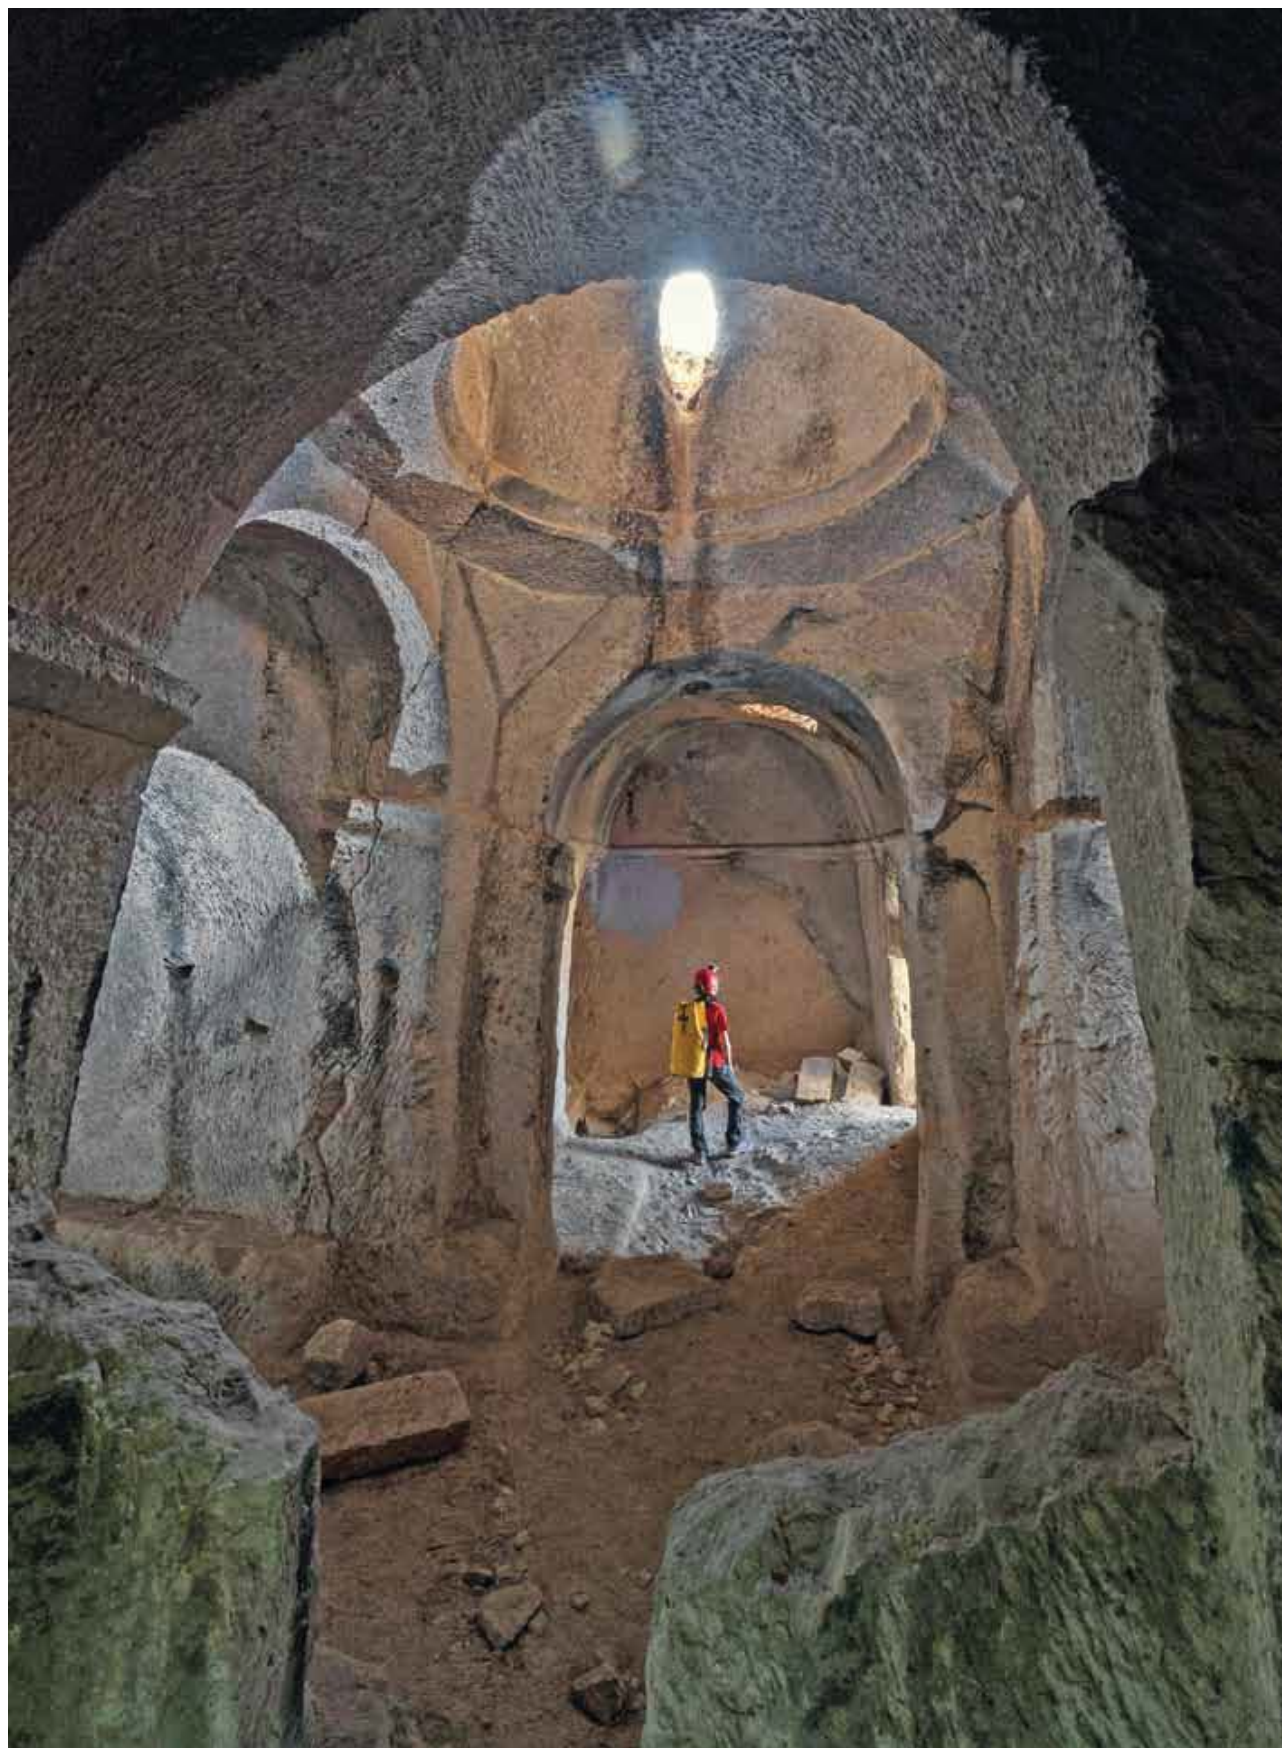
Fig. 16 – Vekse Church No. 1, view from the apse towards the nave and the entrance (photo R. Straub).

on each sides, in the walls two arcossolium niches were carved. In the western part of the southern wall a big arcossolium niche semicircular-shaped in plan-section is positioned. In front of that niche on the floor there is a burial pit. One more burial pit was cut on the floor between two eastern arcossolium niches (fig. 15, fig. 16, fig. 17). One fresco is preserved on the east wall between the apses of the main church and parekklesion. It is preserved fragmentarily but there still could be seen two human figures.

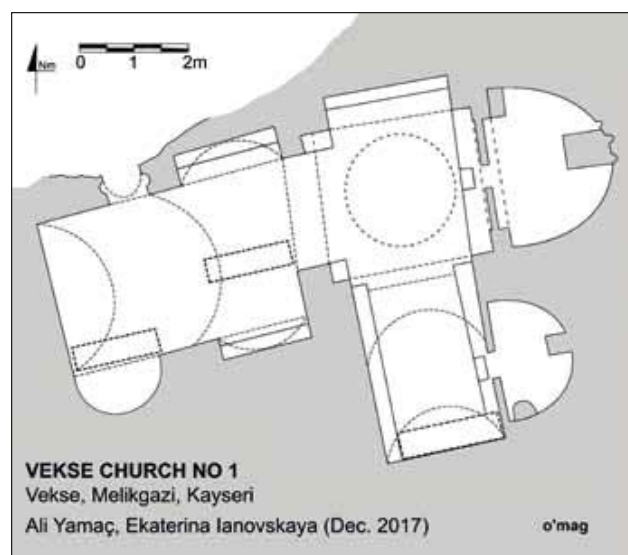
Fig. 17 – Plan of Vekse Church No. 1 (drawn A. Yamaç & E. Ianovskaya).

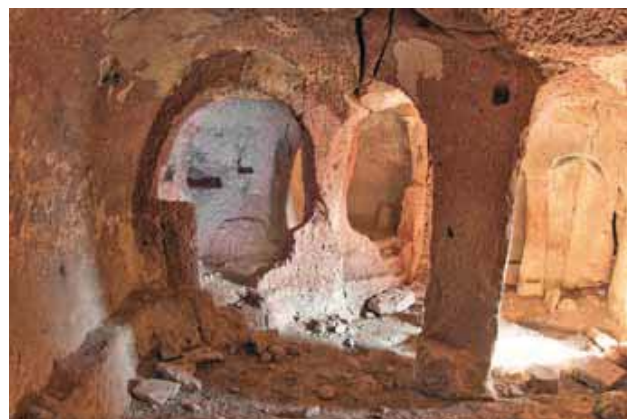
Fig. 18 – Nave of Vekse Church No. 2, looking from west towards east (photo A.E. Keskin).

four different churches along the north wall of the Koramaz Valley. Called Vekse Church No 2 by us, this is a good example of the adaptation of a relatively large rock-cut church to the natural form of the rock body. There are two round arched niches on the east of the nave measuring 3.8×6 m, supported by a single column. The main apse is connected to the lateral apse by a passage to the west. There is a simple templon wall in front of both apses (fig. 18, fig. 19). The total distance between this church, which has no fresco remains insight, and Vekse Church No 3 on the same slope, is about 200 m.

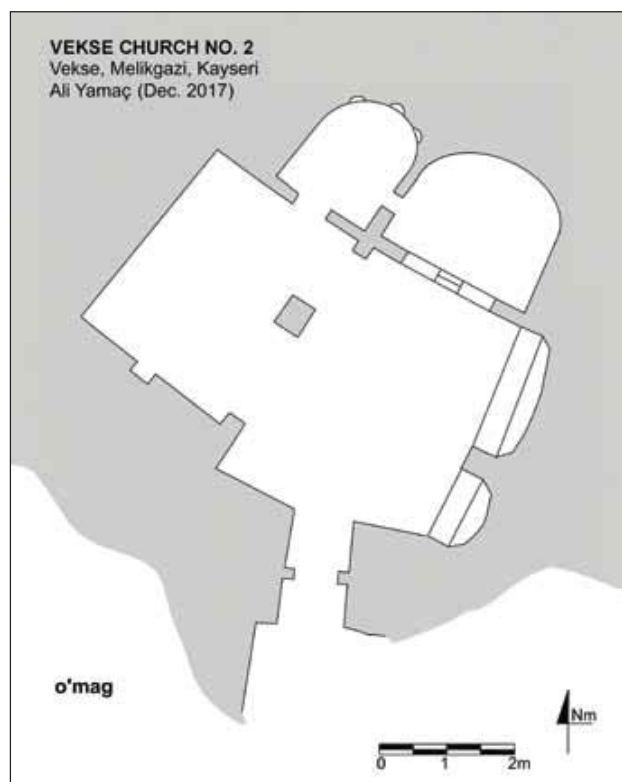
Fig. 19 – Plan of Vekse Church No. 2 (drawn A. Yamaç).

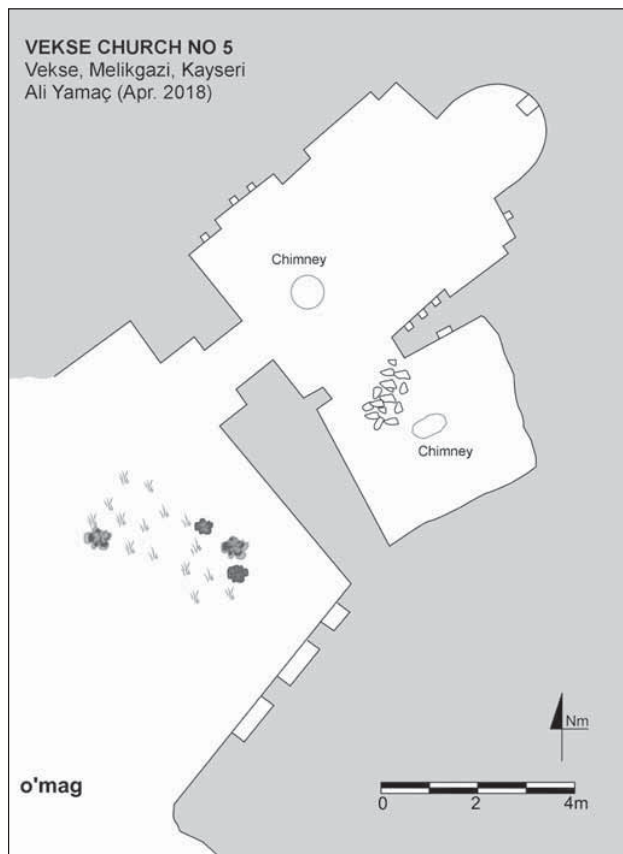
Fig. 20 – Plan of Vekse Church No. 5 (drawn A. Yamaç).

This is the last structure to the east on the northern wall of Vekse. This church, which is located in the middle of the rock wall, on top of the slope, is entered through a rock-carved courtyard that has been excavated neatly and has niches on its walls. On both walls of this 7,5 m long church, there are three large niches with rectangular plan and arches. There is an altar carved into the rock body on the east wall of the horseshoe apse. The purpose of the room, which was dug in the southeast direction inside the church with a nearly square plan and a ventilation shaft in the centre of the ceiling, is uncertain. There is no niche on the walls and the floor is filled with debris fallen from the ceiling (fig. 20).

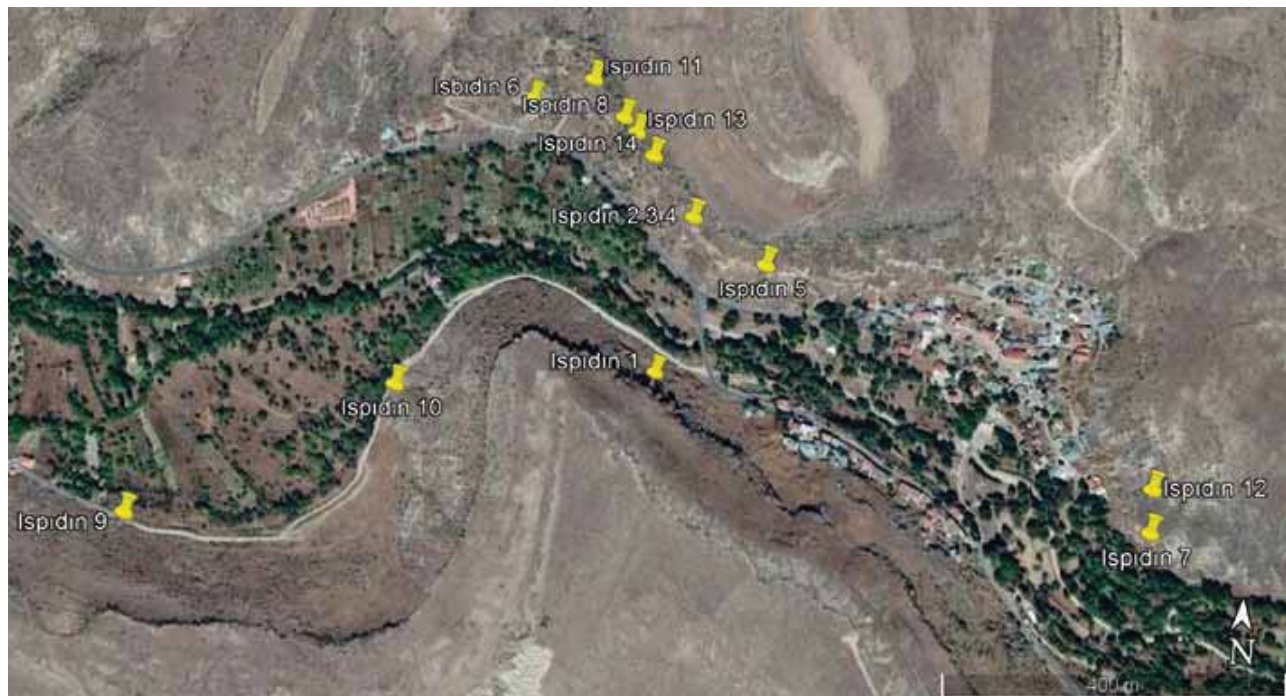
Fig. 21 – Distribution of 14 churches around Ispidin Village (after Google Earth-elaboration A. Yamaç)).

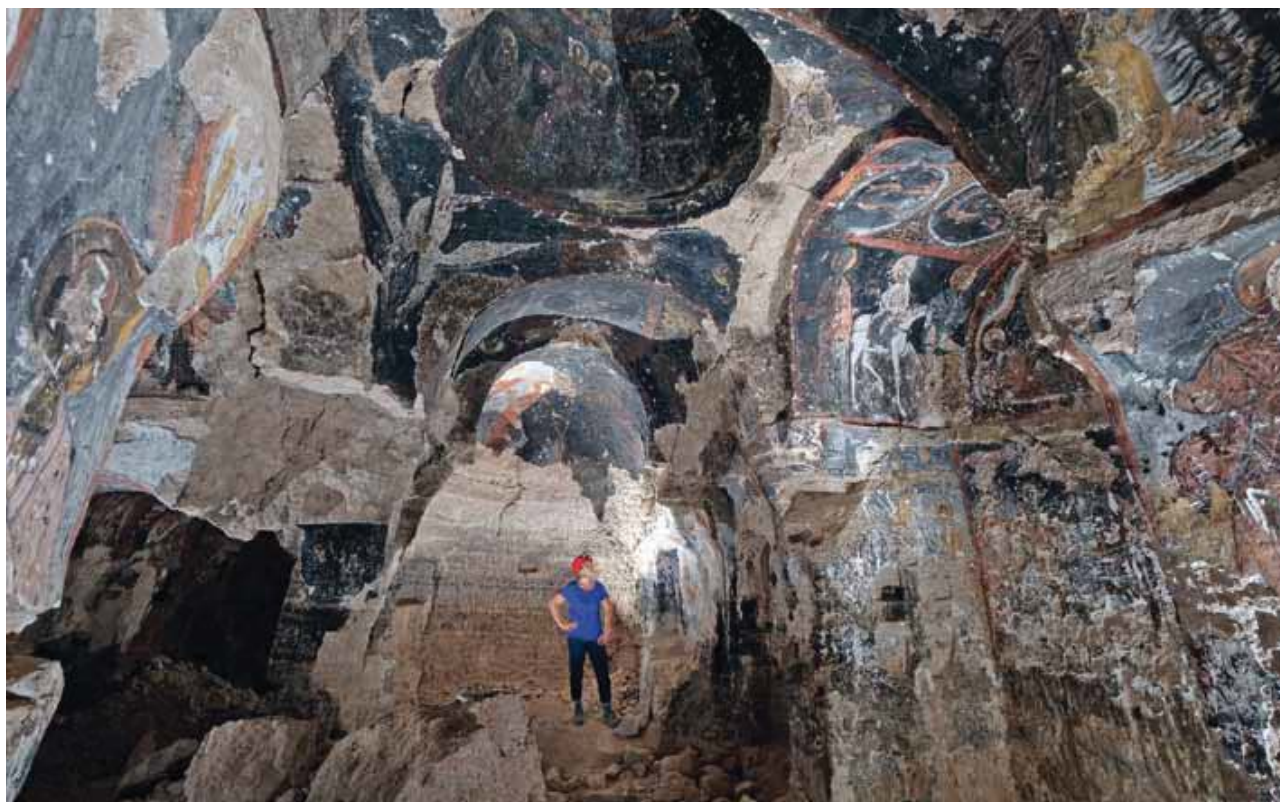
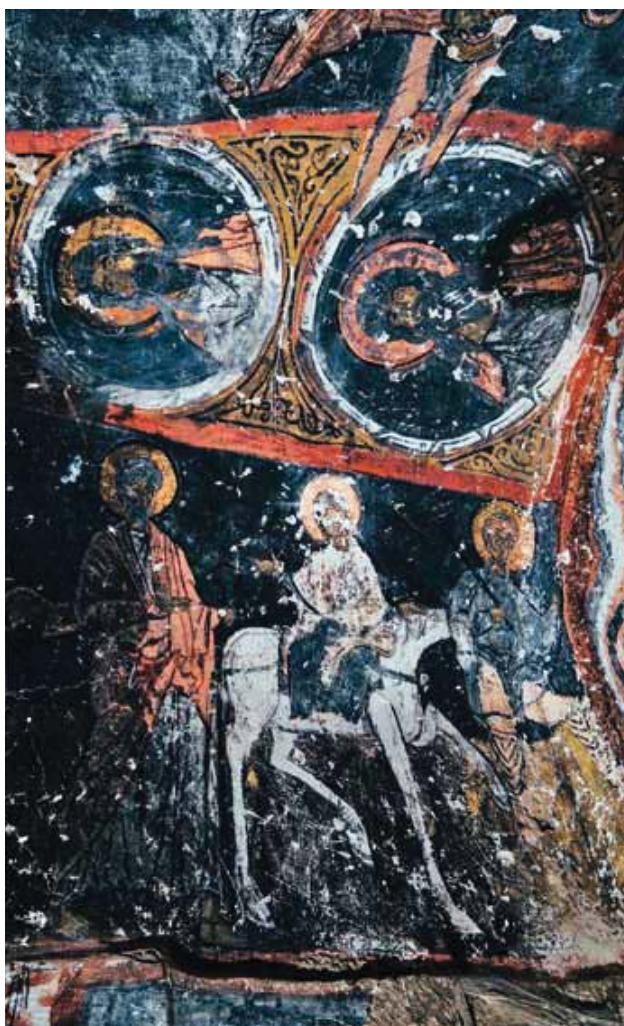
Fig. 22 – Ispidin Church No. 1 (photo R. Straub).

Fig. 23 – Ispidin Church No. 1: detail (photo R. Straub).

we have observed in this church only in the last year is incredible. Most of the frescoes described in Karakaya's article published in 2013 and dated 11th to 13th centuries are now unrecognizable (fig. 22, fig. 23). The church has an irregular rectangular plan and there is a small narthex in the north (fig. 24). The central section where the cross arms meet is square-shaped and covered with a dome that is crossed by pendants. The cross arms, which are rectangular and covered with barrel-vaults, differ in size. The church has northeast and northwest corner rooms. In the east of the cross arm forming the bema, there is a half-round apse and a prothesis in the northeast (Karakaya, 2013; Straub, Yazlık, & Yamaç, 2019).

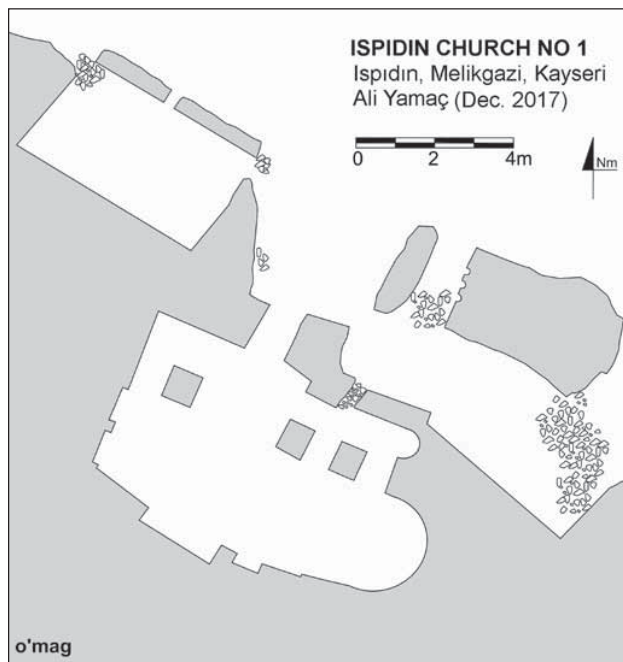
Fig. 24 – Plan of Ispidin Church No. 1 (drawn A. Yamaç).
