Rock-cut Byzantine churches of Koramaz Valley (Kayseri, Turkey)

Ali Yamaç¹

Abstract

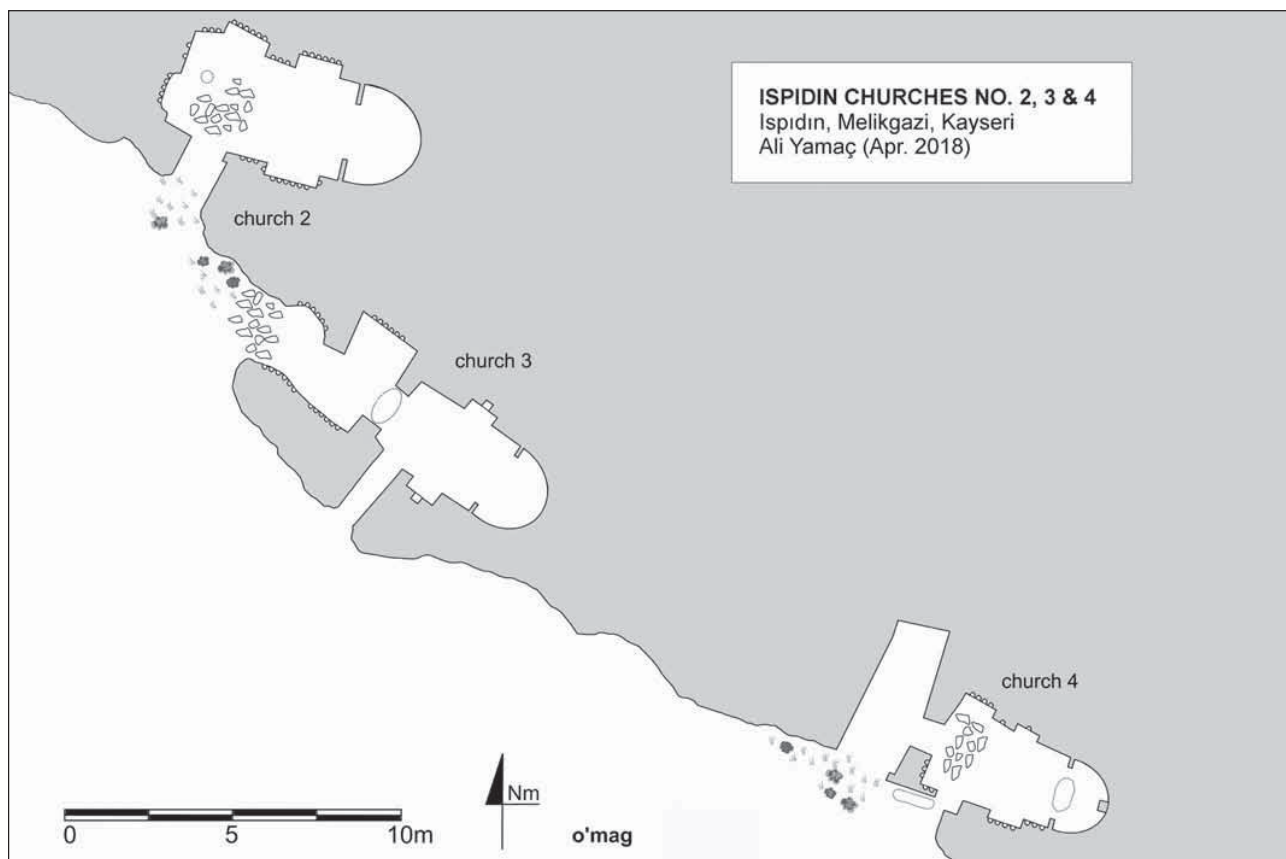
Fig. 25 – Plan of Ispidin Churches No. 2, 3 and 4 (drawn A. Yamaç).

To the north of Ispidin Church No 1, on the rocky slope opposite the bridge, there are three small churches, which are separated by 10-15 m and are very similar to each other in terms of architecture. The church number 2 in the west direction, like the other two, is in the northwest-southeast direction and has an amorphous rectangular plan. The ceiling is barrel-vaulted

and the naos is full of debris due to illicit digging in front of the horseshoe-shaped apse. Numerous small niches partly on the walls and on the architrave and the chimney in front of the entrance show that the church was once changed to a dovecote.

From this church to the southeast, Ispidin Church No 3 is located on the same rocky ridge. Unlike the church no 2, there is a narthex in front of the western entrance of this building, which was later turned into a dovecote. The church has an entrance from both the south and the narthex. There is a rectangular niche with round arches on both walls of the naos. Ispidin Church No 4 is located 15 m southeast of Ispidin Church No 3, along with its narthex with a very smooth architecture. The building, like the other two churches, has a semi-circular apse and a barrel-vaulted ceiling (fig. 25).

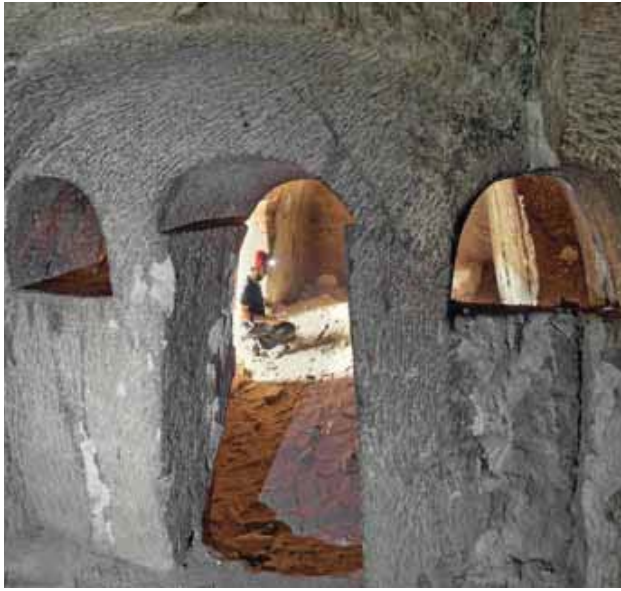
Fig. 26 – Ispidin Church No. 5 (photo A.E. Keskin).

The church is entered through a door on the rocky slope facing south and to the valley. The building has a rectangular plan measuring 7.5×2.5 m in the north-west-southeast direction. The ceiling of the building has a barrel-vault, and there are four square-shaped, round-arched niches and a transept lined side by side on the north wall of the naos. As the rock block in the southern part of the church was too thin to allow a

transept arm to be excavated here, just like Vekse Church No.1 only one arm of the transept was made. The only feature of this small church, which has no fresco today, is the templon wall with windows that separates the apse and the nave. (fig. 26).

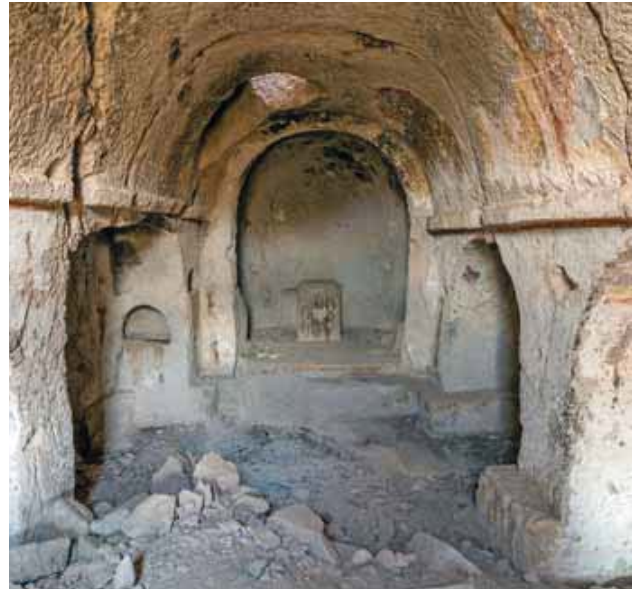
Fig. 27 – Ispidin Church No. 12 (photo D. Albov).

Located on the eastern end of Ispidin, 20 m above Church No. 7, this building is another frescoed church in the region. Although a few fragments of these frescoes remain, the few human motifs that can be detected are remarkable. This building, which can be regarded as one of the largest churches in the region with its dimensions of 3.5×8.5 m, has a barrel-vault, a semi-circular apse and has a very elaborate architecture and workmanship. The altar on the east wall of the apse is carved into the rock body. The function of the room measuring 3.5×4 m, which is connected to the church with a large entrance from the south and which has been possibly excavated in the same period, is uncertain. There is a *mihrab*-like niche on the south wall of this room, the southwestern corner of which has collapsed (fig. 27, fig. 28).

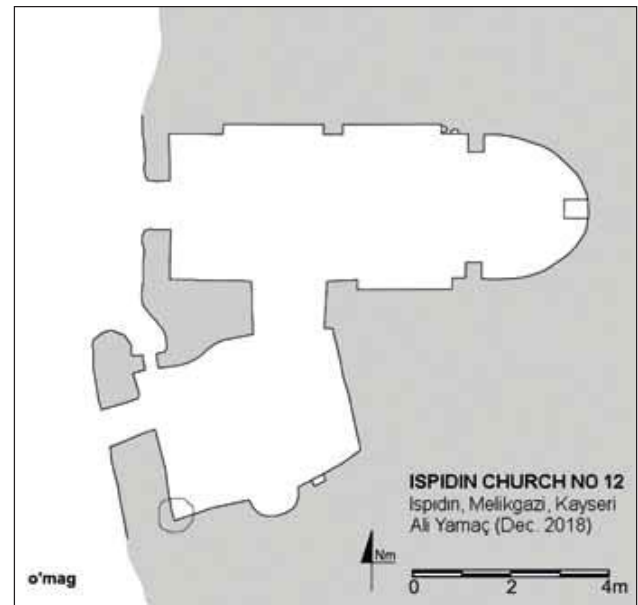
Fig. 28 – Plan of Ispidin Church No. 12 (drawn A. Yamaç).
