# Non-destructive field measurement for investigation of weathered parts – Case study at the Taya Cave, Central Japan

Chiaki T. Oguchi<sup>1</sup>, Kaisei Sakane<sup>1</sup>, Yasuhiko Tamura<sup>2, 3</sup>

Non-destructive measurements are useful methods for evaluating weathering degree without any damage on geoarchaeological sites. The present study aims to extract the deteriorated parts by using Silver Schmidt Hammer and ultrasonic pulse velocity tests on the Taya Cave in Yokohama city. It is a manmade cave excavated from Kamakura to late Edo periods. Many sculptures and reliefs were carved on the surface of the cave wall made of soft rock. The cave has a complex three-layer structure with a total length of 570 m. Firstly, distribution maps showing cracks and exfoliation parts were created. Then, the points showing low rebound values and slow ultrasonic pulse velocity were plotted on the same map. The results of these non-destructive on-site measurements shows that many dangerous parts were turned out within the worship route. Especially, the complex excavation point in the center of the cave found to be the place where collapse measures must be taken first.

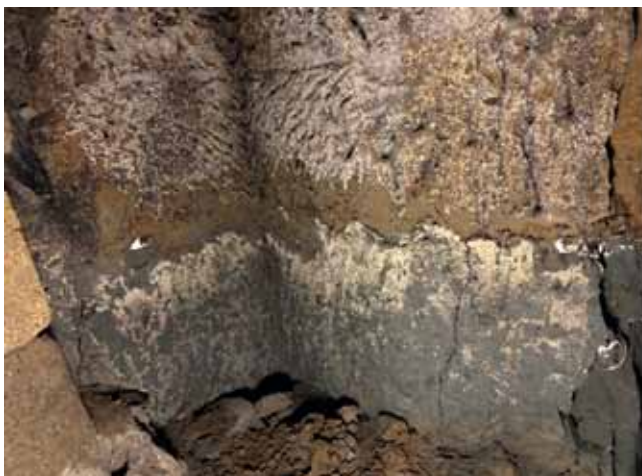
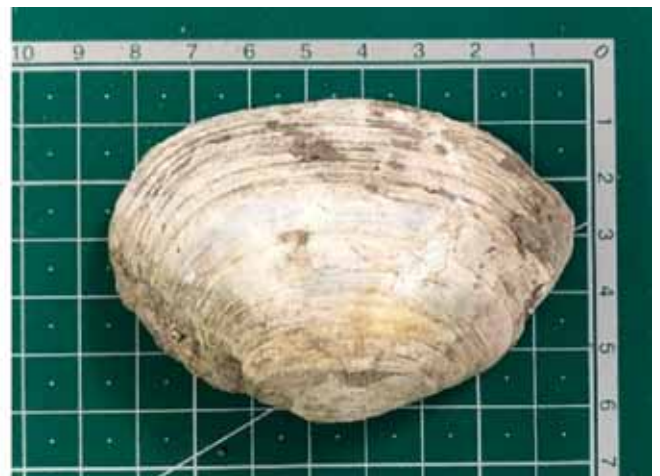
Fig. 3 – (a) Boundary between upper and lower Naganuma formations (photo: C.T. Oguchi) and (b) an example of shell fossil buried in the lower Naganuma formation (photo: Watanabe).

of the Naganuma Formation shows dark grey silts, including large shell fossils (fig. 3). The upper layer of the formation shows brown sandstones with fine to medium grain size in the upper layer. The boundary between the two layers can be observed inside the cave.

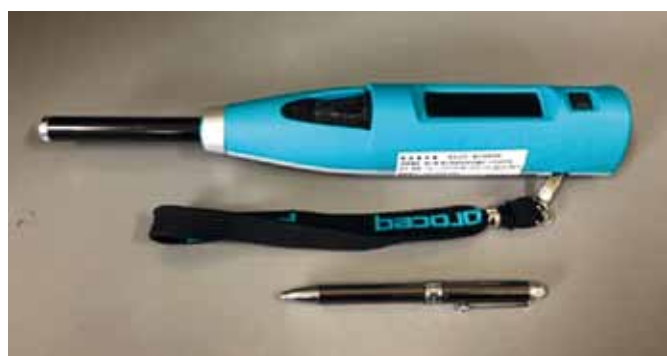
Silver Schmidt Hammer (fig. 8) is a non-destructive testing machine, also called a rebound Hammer. The ratio of the rebound speed to the striking speed of the internal spring (rebound speed ratio: Q value) is calculated using the same principle as the echo chip hardness tester. Since it is rechargeable, and does not require correction based on the striking angle, it could be used without inconvenience even in a narrow cave.

Fig. 8 – Silver Schmidt hammer (photo: Sakane).
