# Hypogea 2015

## THE COZZO DISI MINE (CASTELTERMINI, SICILY, ITALY) A MULTI-DISCIPLINARY APPROACH TO RECORD, STUDY, PRESERVE AND DEVELOP THE MINING HERITAGE IN SICILY

Cozzo Disi was one of the main sulphur mines in Italy, but after the closure and more than 10 years of desertion, urgent works are now necessary to save it from vandalism and flooding. This big mine contains geological and mineralogical peculiarities, so uncommon to be sometimes unique: this is the case of the “Grandi Garbere” at 3<sup>rd</sup> level, majestic karst cavities, containing magnificent selenite crystals documented by old miners. The possibility to have a “Sicilian Naica” attracted a multi-disciplinary underground task-force, now exploring the mine underground, in order to inspect old works and their good-safety conditions, and to achieve the rooms/caves of “Grandi Garbere”. This extraordinary discovery should be relevant for the future of this territory. In the past, the mine was characterized by huge safety problems: hydrogen sulfide, carbon dioxide and explosive atmospheres; so, the team involved in actual and future explorations has to move with caution, using adequate equipment and - if necessary -

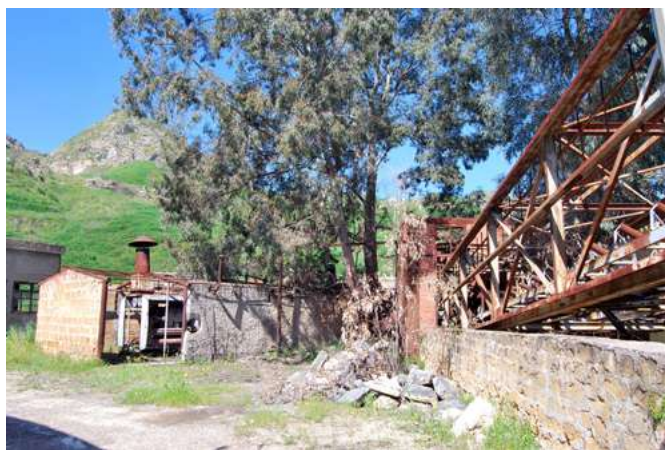
Fig. 1: view of the outside structures of the Cozzo Disi mine, in the 2014 spring (photo F. Fiorenza).

In November 1990 the Sicilian Mining Administration – which had the property of the whole sulphur mining district – delivered the mine to the Sicilian Region; in this way, maintenance and pumping stopped and the mine was abandoned to plunder, vandalism and flooding (Fig. 1).

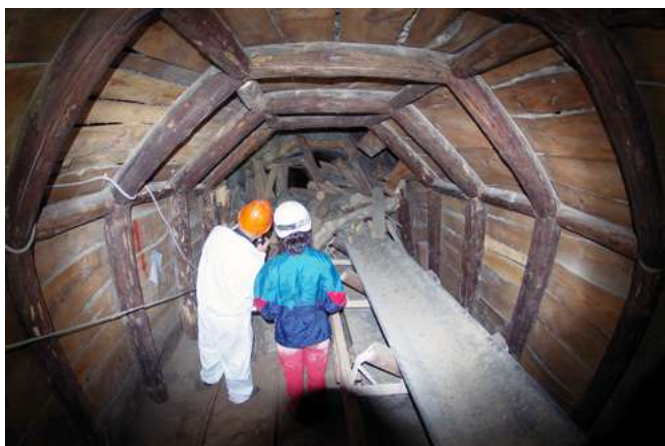
Fig. 2: the "Floatation" tunnel during inspections of May 2014 (photo G. Badino).

Unfortunately, until 1996, nothing was actually done; then, a regional law allocated a billion of old "Lire" for the "safeguard of the underground infrastructures of the Cozzo Disi Mine-Museum". This funds allowed the restoration of the "Floatation" tunnel (Fig. 2), and of another gallery (Canalotto) located 15 metres below, connected to the first one with an underground circular track should be already accessible to the public, which demand insistently to visit the site.

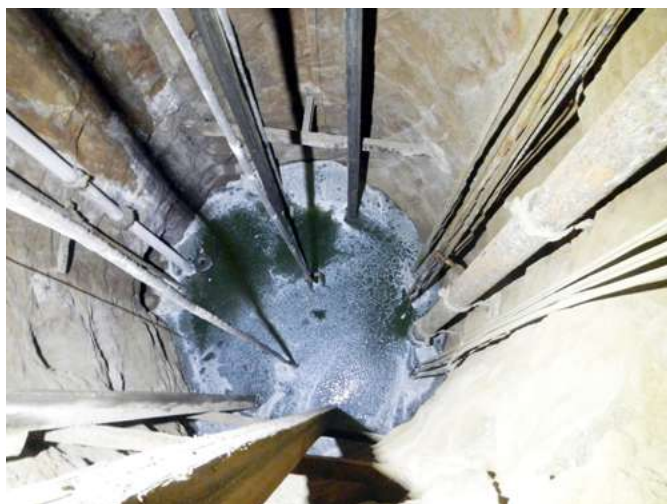
Fig. 4: view of the Main shaft, from the 5th level gallery, in 2014 May (photo M. Vattano).

elevator shaft and to measure the height of the water table, just below. Its level is 7.09 m from the floor of the 5<sup>th</sup> level (Fig. 4).

To show to visitors these natural wonders it is necessary to restore some old tunnels and realize new lifts; the main, urgent problem is now pumping waters to save the mine, after 10 years of abandonment (Fig. 4).

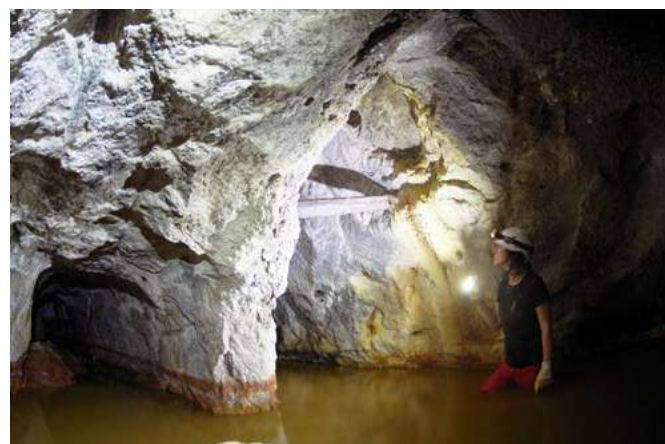
Fig. 6: 3<sup>th</sup> level gallery partially flooded (photo G. Badino).

A first heavy exploration started in March 2013 with a descent at the 3<sup>rd</sup> level (Fig. 6) of the mine, trying to reach directly the “Grandi Garbere”.

The team entered the “Gallery Canalotto” and, along the “Via Operai”, reached the 3<sup>rd</sup> level. The gallery was flooded by about one meter of water, the air was of poor quality, whilst the high temperature and the pungent and persistent sulphur smell made the progression very difficult.

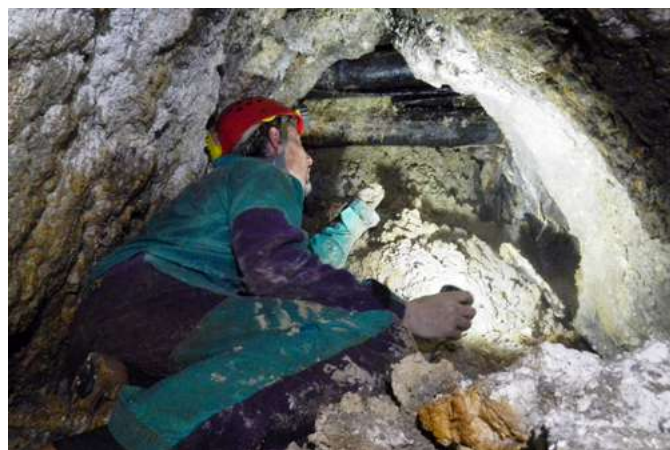
Fig. 7: view of the debris deposit, in the final sector of 3<sup>rd</sup> level gallery. This landslide block the passage to “Garbere” (photo M. Vattano).

The main gallery is closed by a landslide (Fig. 7), particularly unstable and with breakdown deposits that touch the ceiling; to the right, a stone wall closes inexorably a possible by-pass. Exploration is planned for the next year, after partial demolition of the landslide deposit.

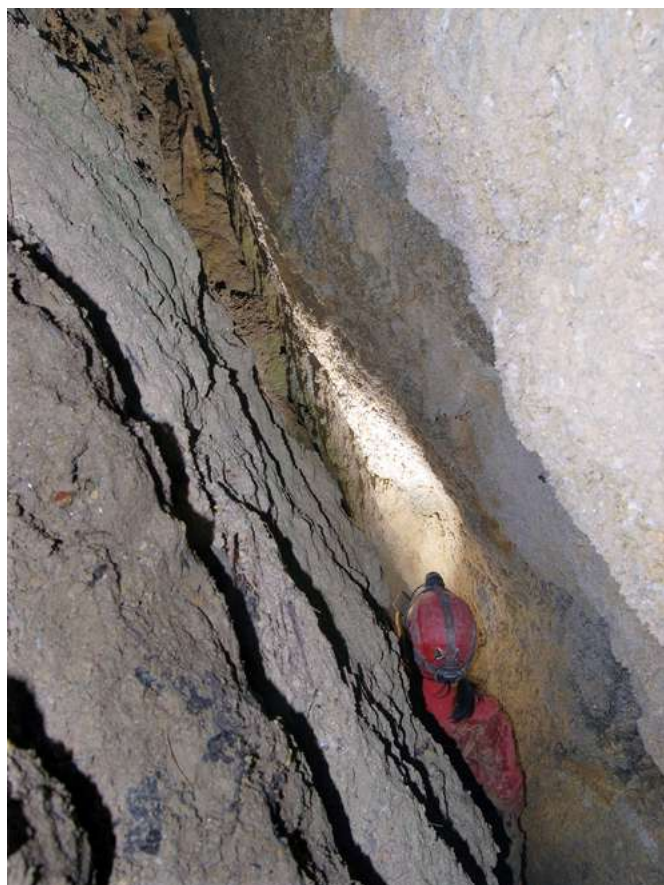
From the higher entrance, equipped with rope for vertical progression, it is possible to explore the narrow fracture for about ten meters in western direction, and just a few meters downward (Fig. 9), up to a narrow passage. The extreme instability of the multiple collapsed boulders around the fracture prevents any attempt to dig. There is a considerable cold airflow toward the entrance, probably due to local circulation. On the walls there are abundant gypsum speleothems in selenite shape, tabular and acicular, centimetres in

Fig. 9: speleological explorations inside one of the surficial fractures (photo F. Fiorenza).

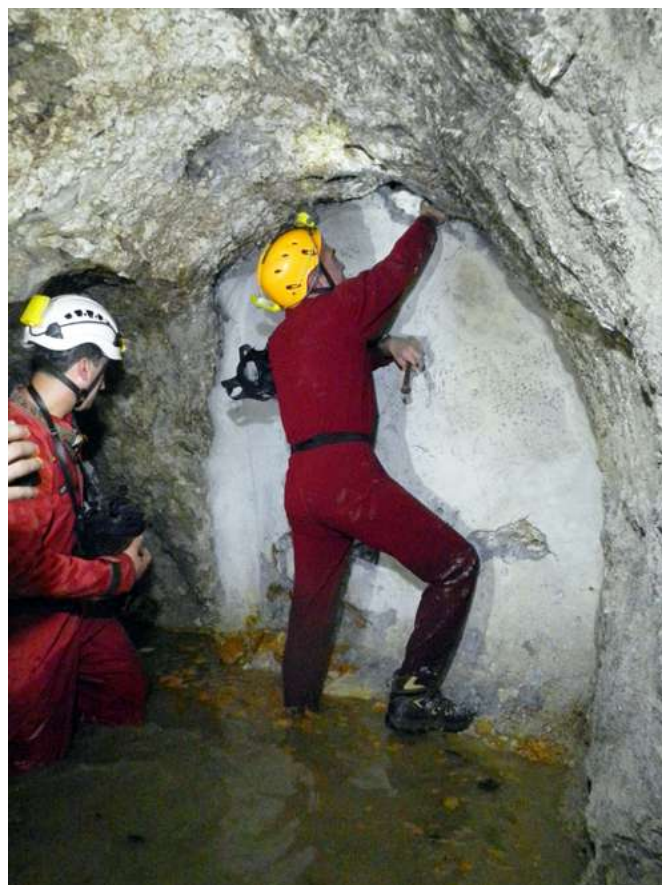
Fig. 10: the 3<sup>th</sup> level gallery which ends on the gypsum blocks man-made wall. Over this the passage is blocked by the debris deposit (photo M. Vattano).

looked reddish, probably also due to the deterioration of some tracks now completely submerged. In its final parts, just before the wall beyond which there should be the Garbere, there was a small concrete dam (Fig. 10); the water behind it was deeper and white-gray in colour.

We used gas detectors in some holes in this wall, finding low concentrations of hydrogen sulphide, and then began the removal of some elements of the wall itself. Behind this artefact, made by gypsum blocks aggregated by cement mortar, there was a further collapse made of brown clays soaked in water, which had broken the wood armours. It was impossible to pass through this point also because the water-saturated clays might also contain some harmful gas pockets.

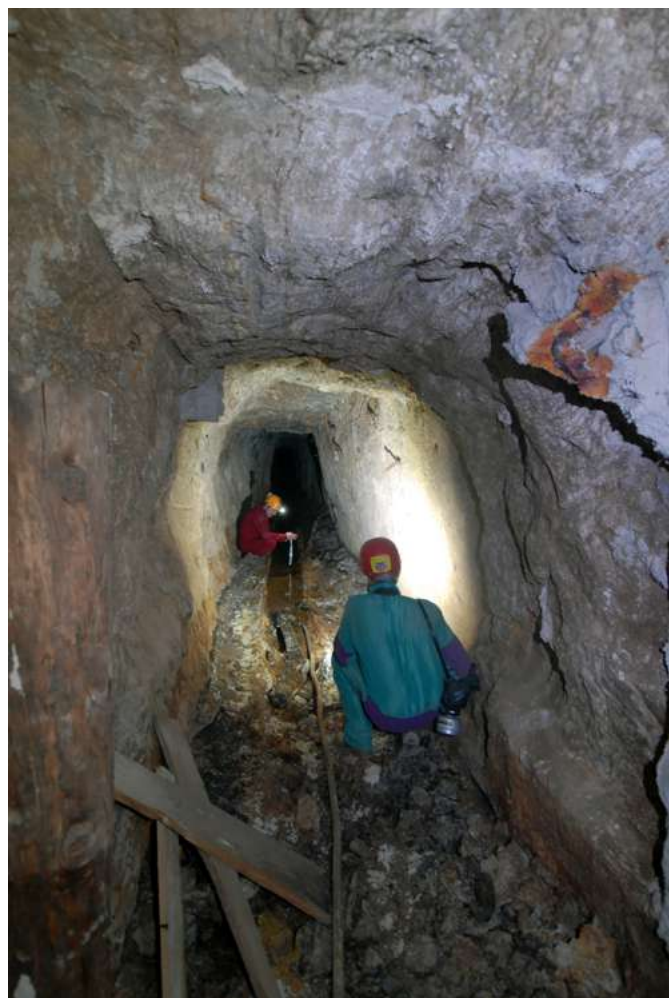
The following day we found a temperature increase in this area, probably due to a circulation of air in a "horseshoe", with cooler air flowing on the water surface in circular pattern, to then stand on the roof. This mechanism cools air and water in the area closest to the first part of gallery.

Fig. 11: air circulation analysis and topographic activities in the 3<sup>rd</sup> level gallery (photo M. Vattano).

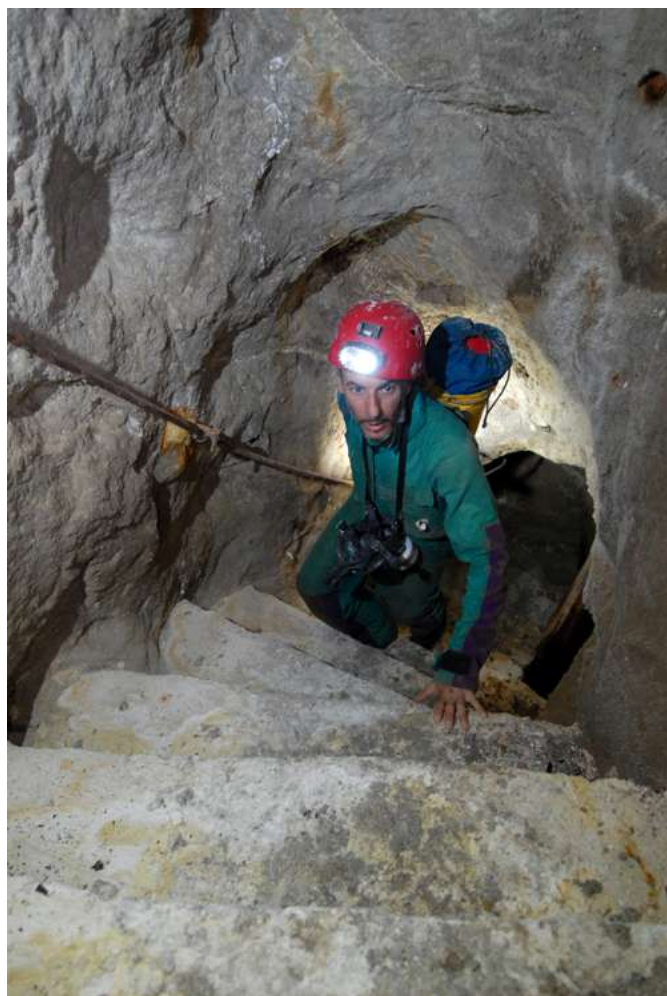
We went down quickly along the “Via Operai” (Fig. 13),

Fig. 13: climb-up on to the “via Operai” straicase (photo M. Vattano).

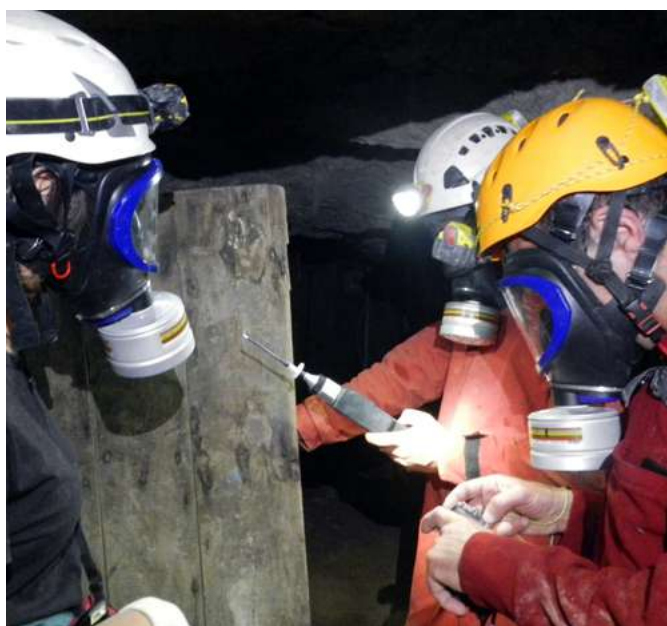
There was an increase of H<sub>2</sub>S concentration, up to 1.1 ppm (Fig. 14), but this disappeared at the entrance to the gallery of this level, crossed by a strong air flow.

Fig. 14: check of level of dangerous gas before the access in the 5th level gallery (photo M. Vattano).
